Taking No Prisoners Beating Back Invasive Species

**Leonard Willett - Lower Colorado Region
Renata Claudi – RNT Consulting Inc.**

U.S. Department of the Interior
Bureau of Reclamation

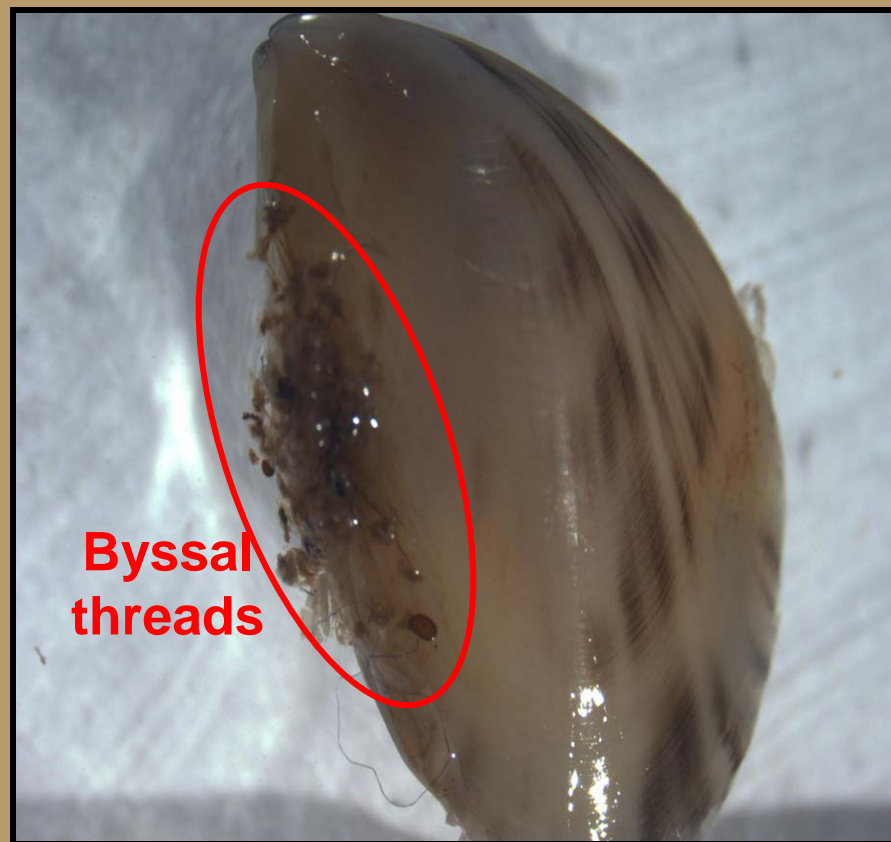
Quagga mussel, Lake Havasu – Jan. 2007

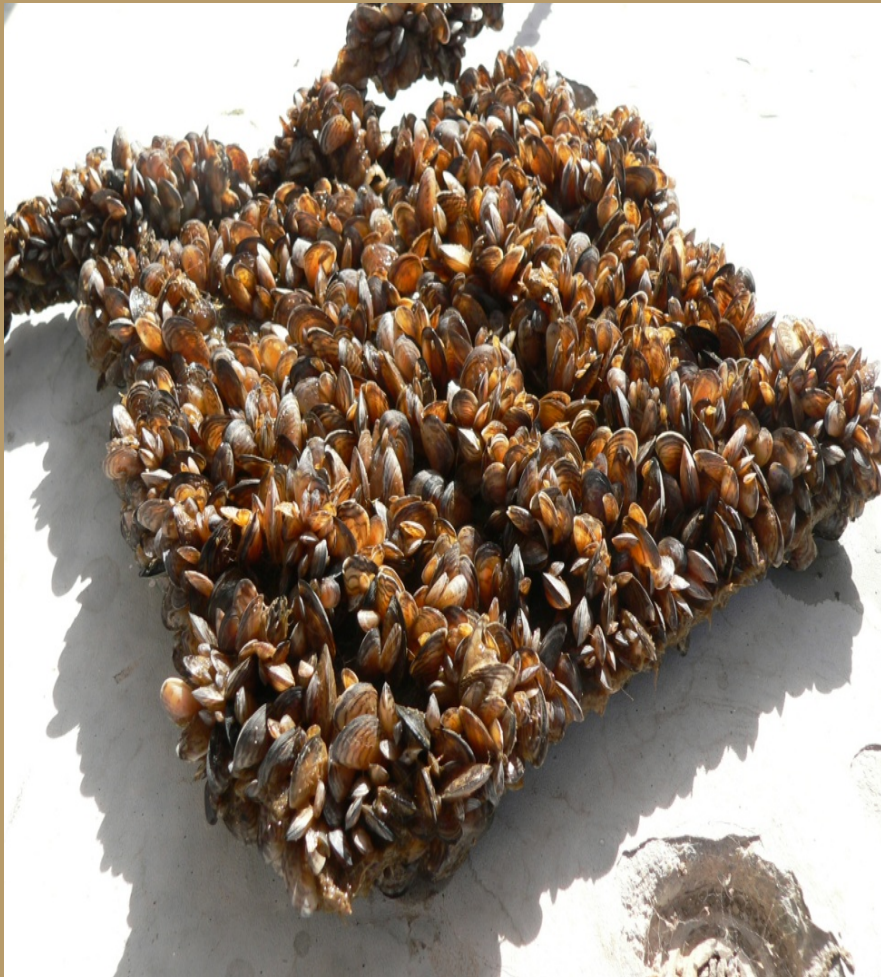
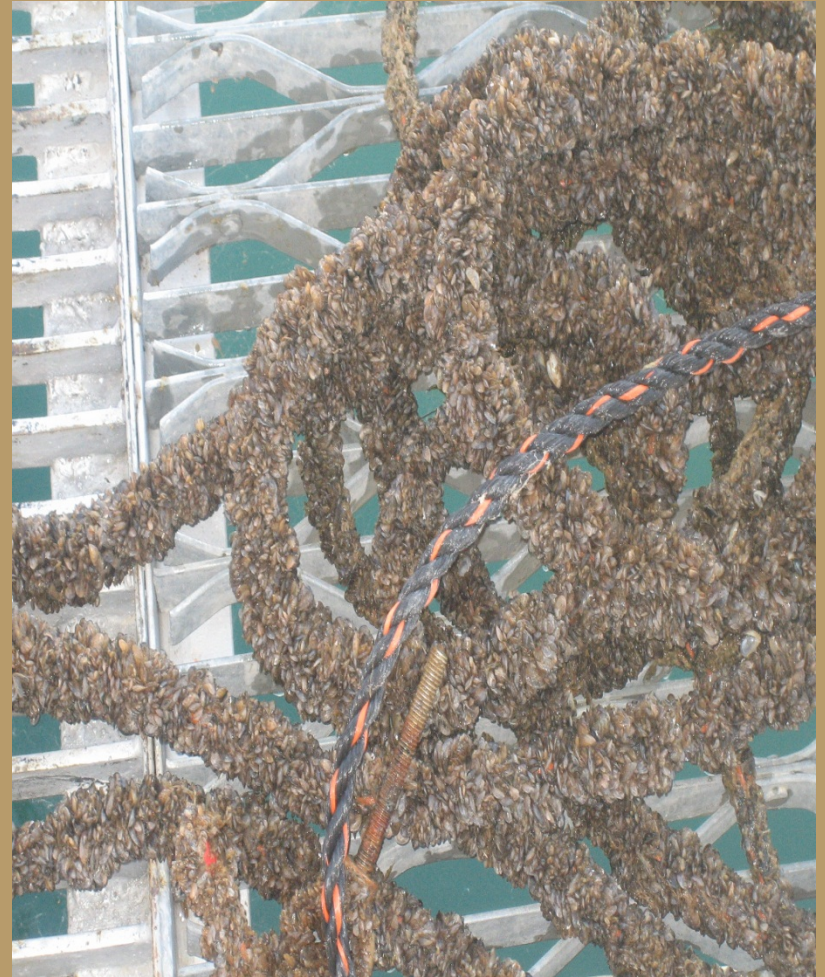
Sampling Plates at Parker Dam

November 11/07 – 6 Weeks of Settlement

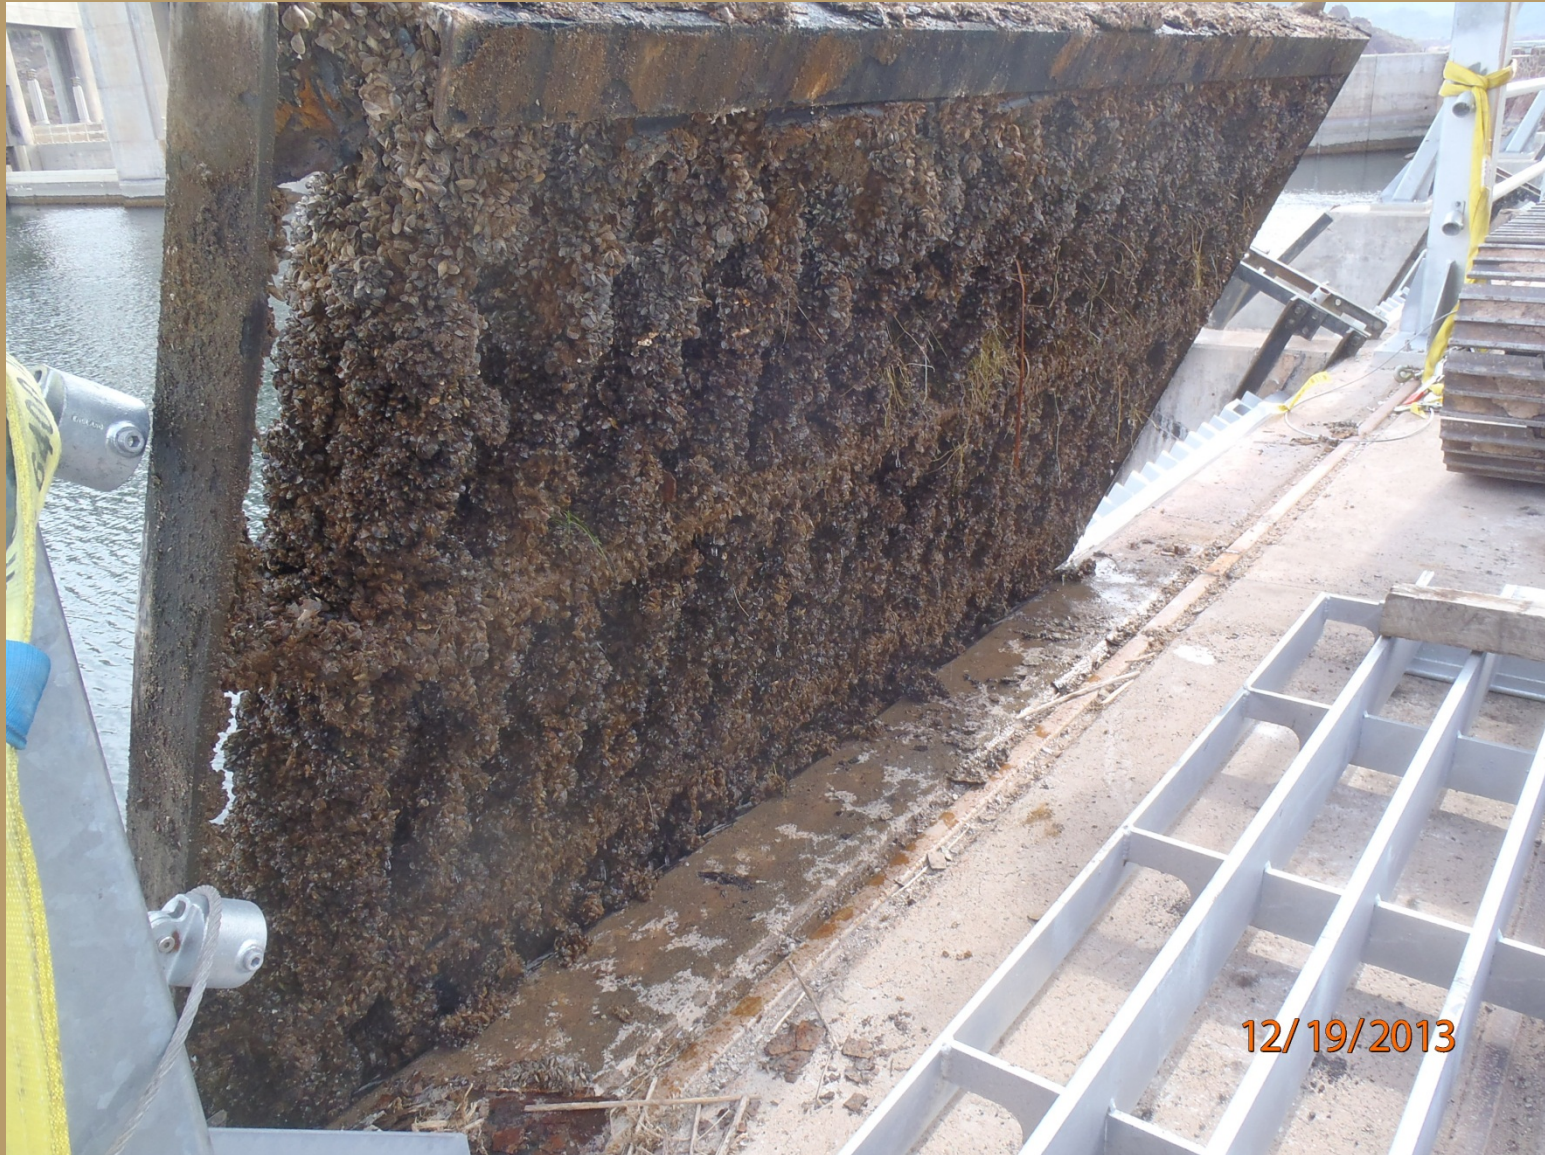
Trash Rack- Parker Dam - Jan 2013

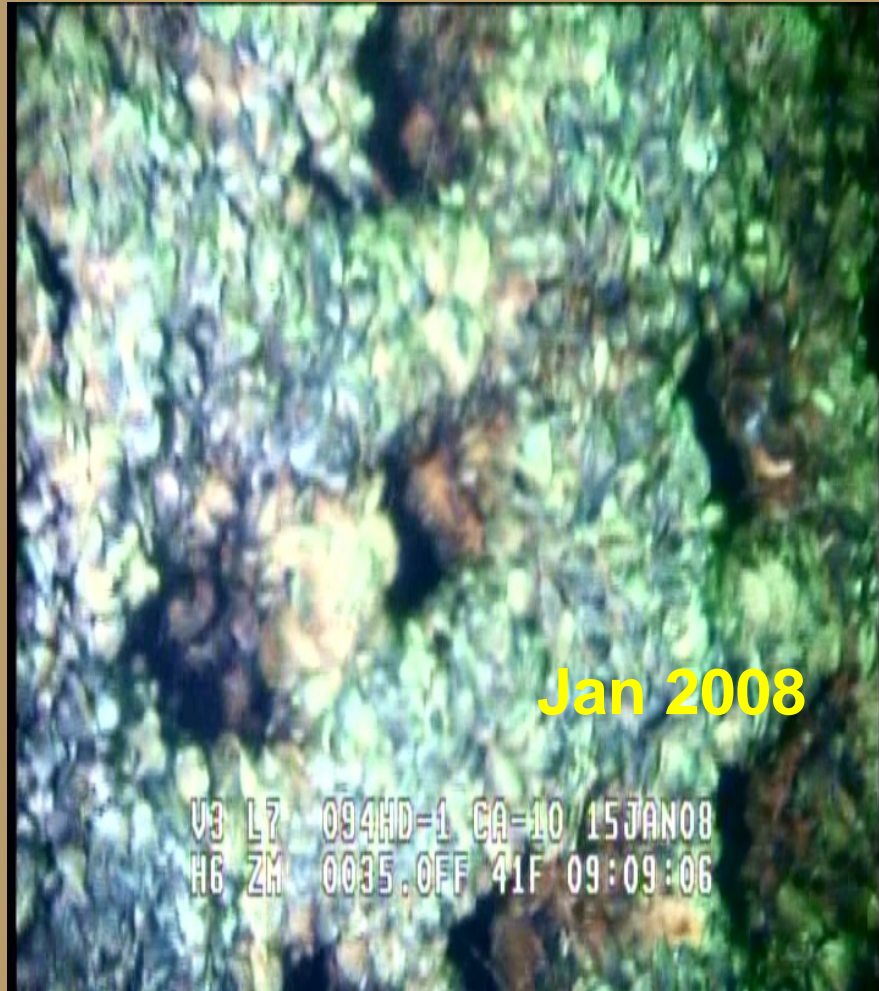
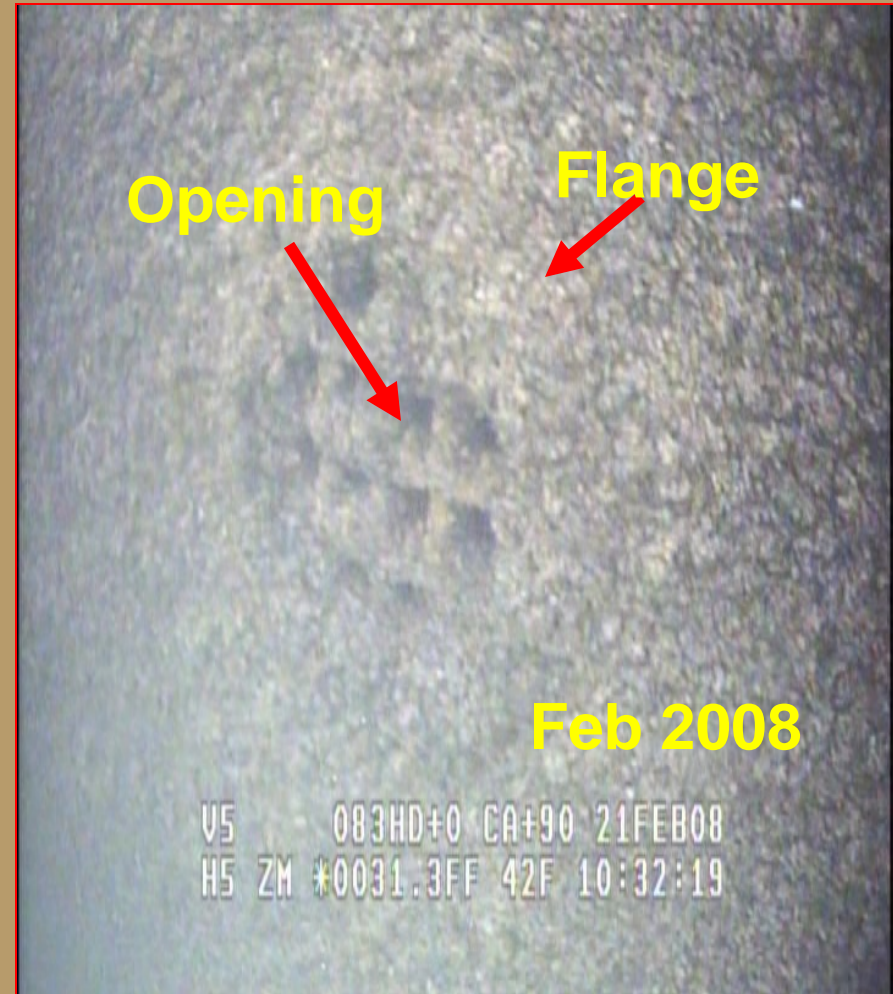
Domestic Water Intake Parker Dam

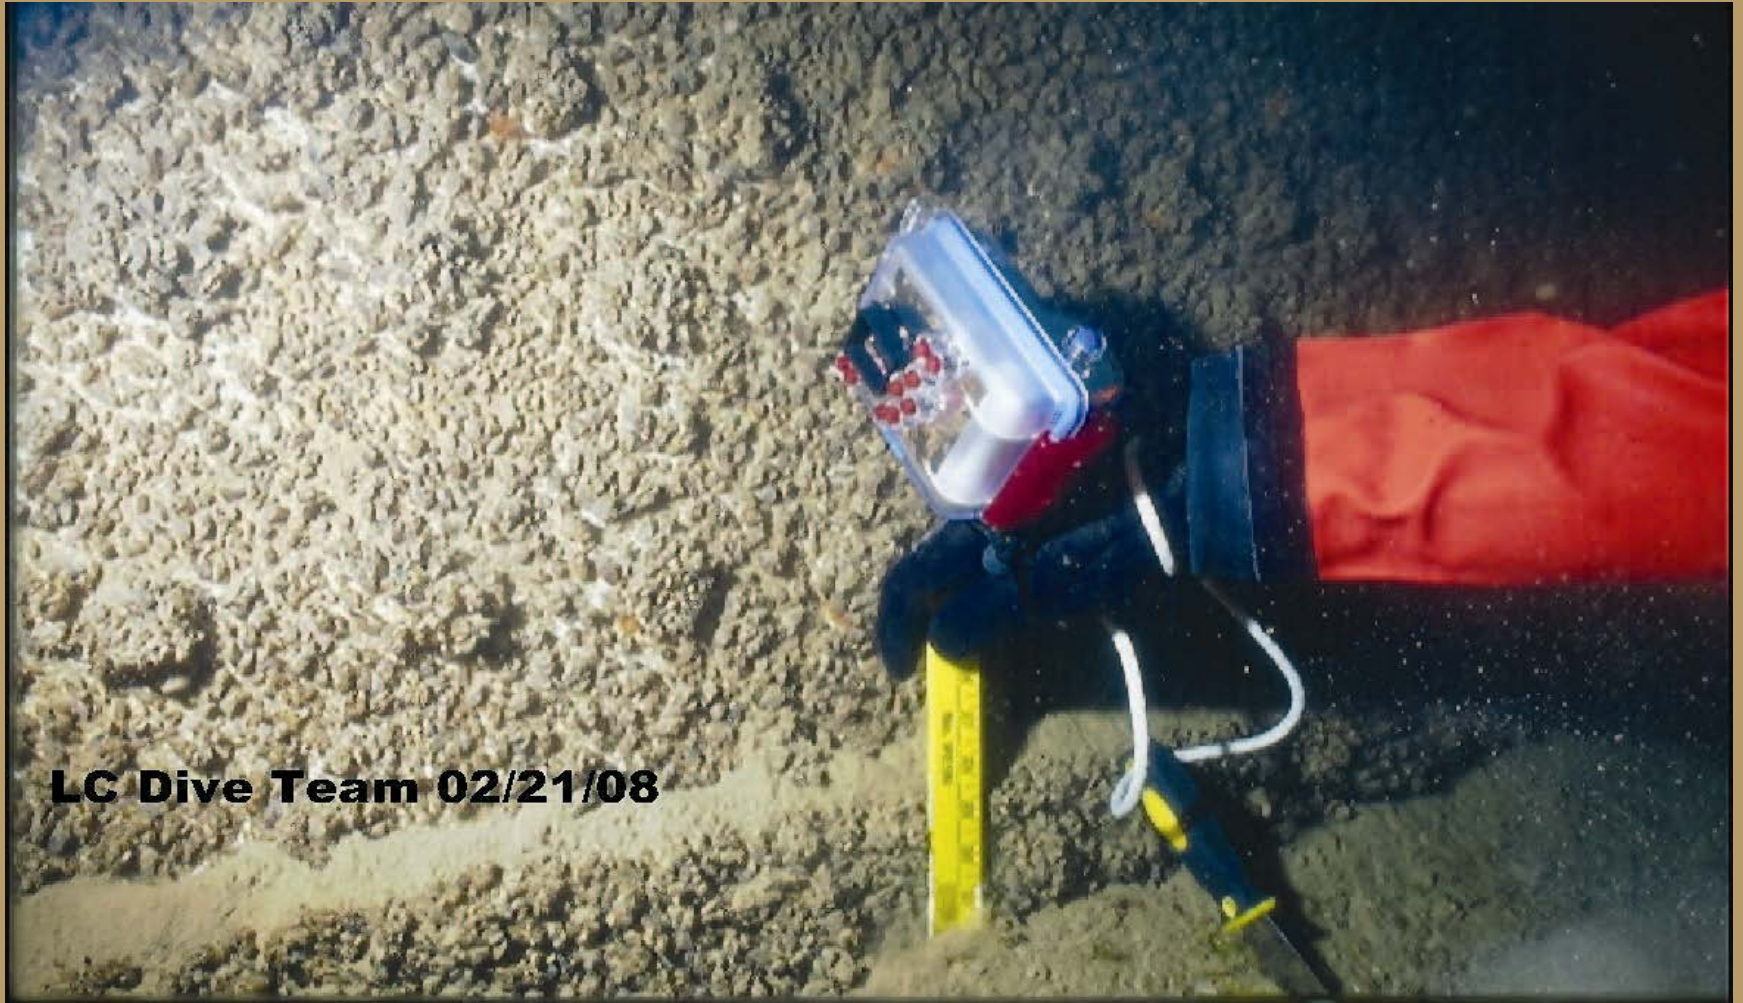
Spillway Gates – Parker Dam

LC Dive Team 02/21/08

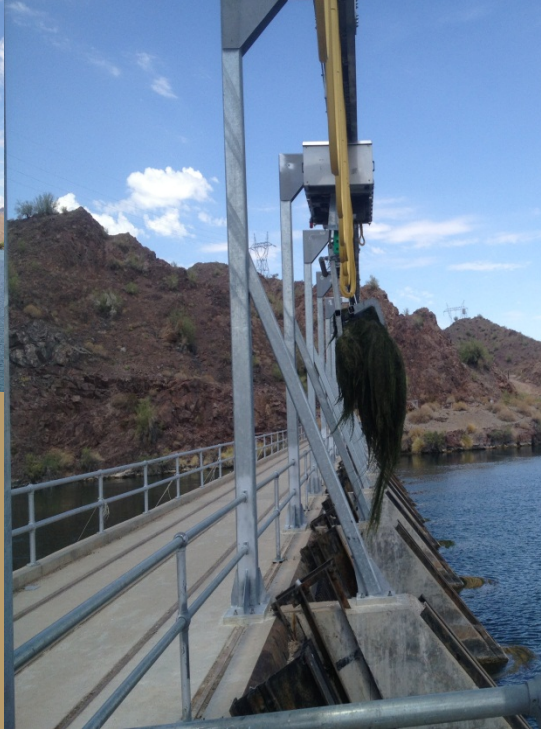
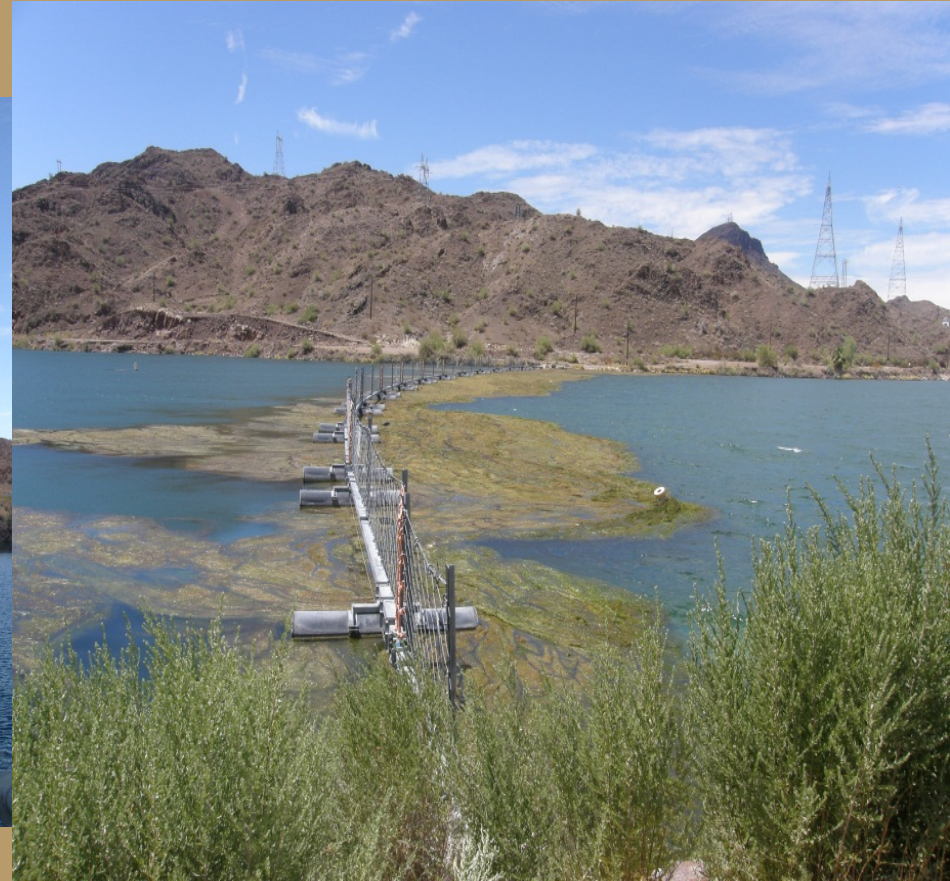
Parker Dam Trash Rake – Sept 2013

- Evaluate weeds and intake design. Retrofit of trash bar screens with racking systems (Parker Dam)
- Evaluate impacts of mussels on reservoir water quality and environmental impacts.

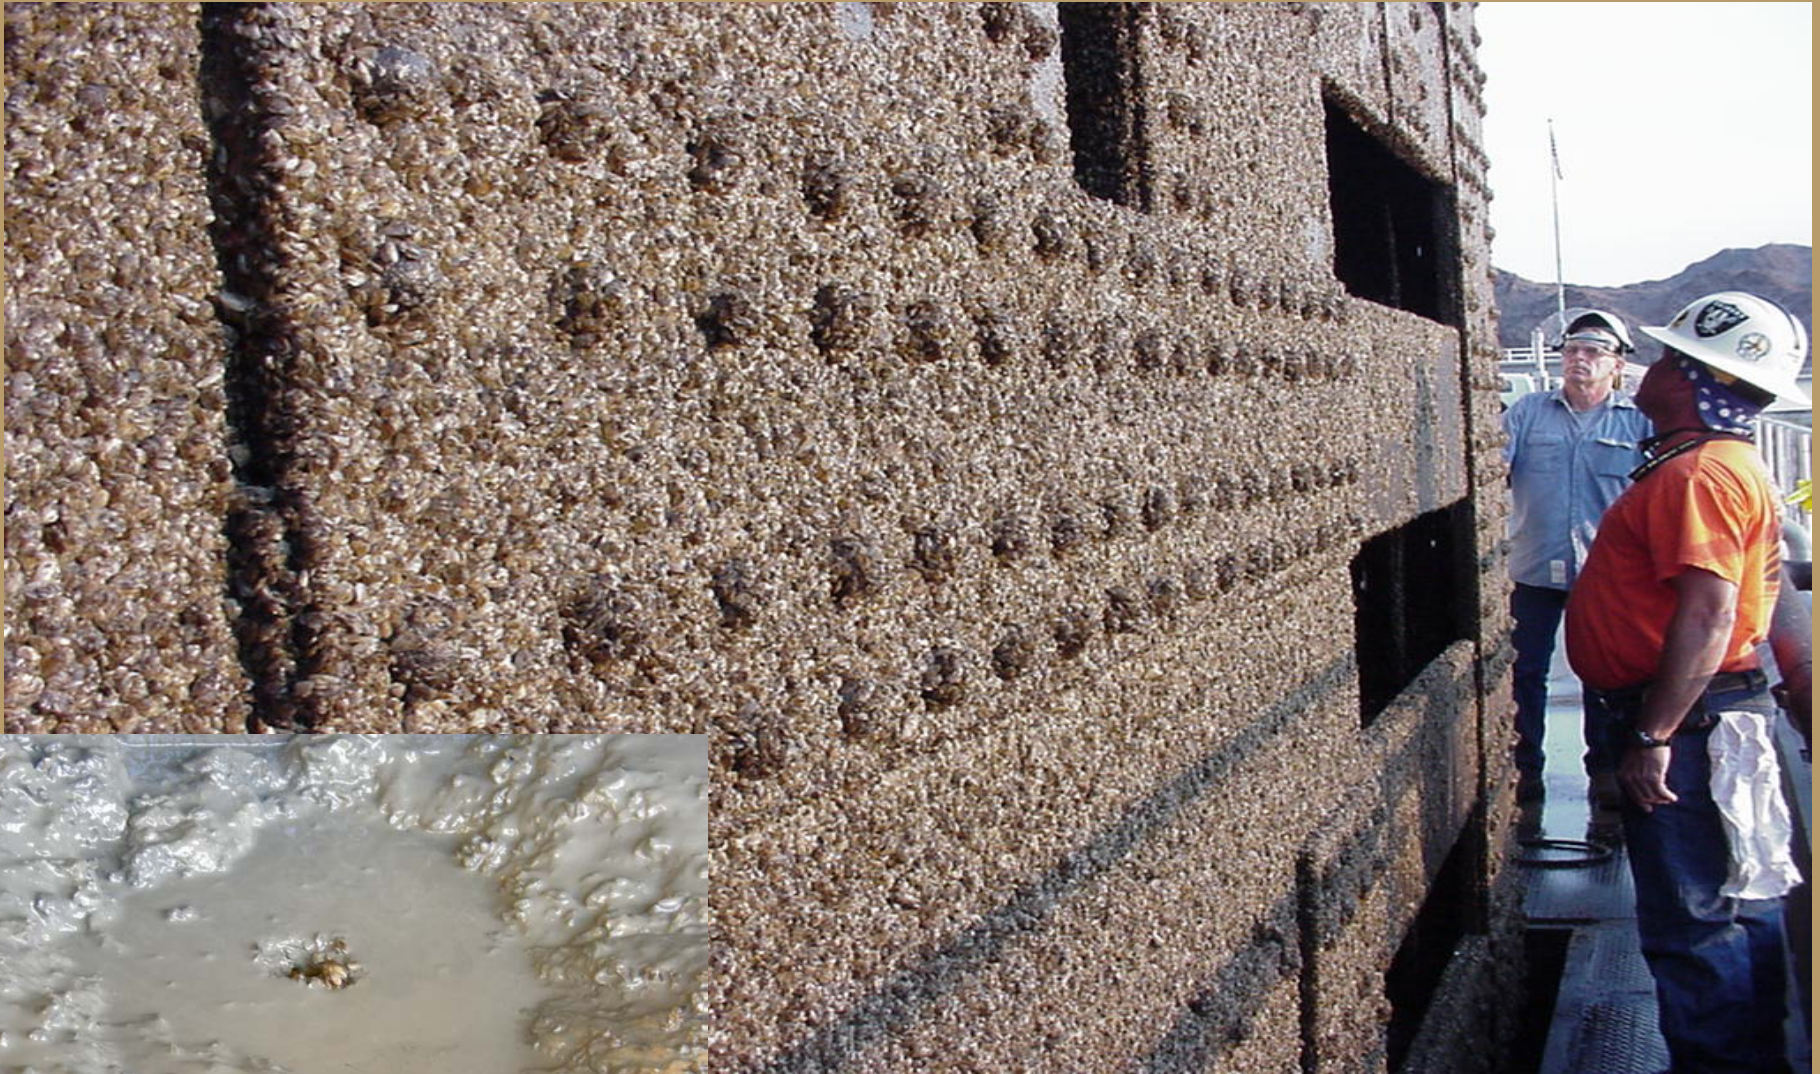
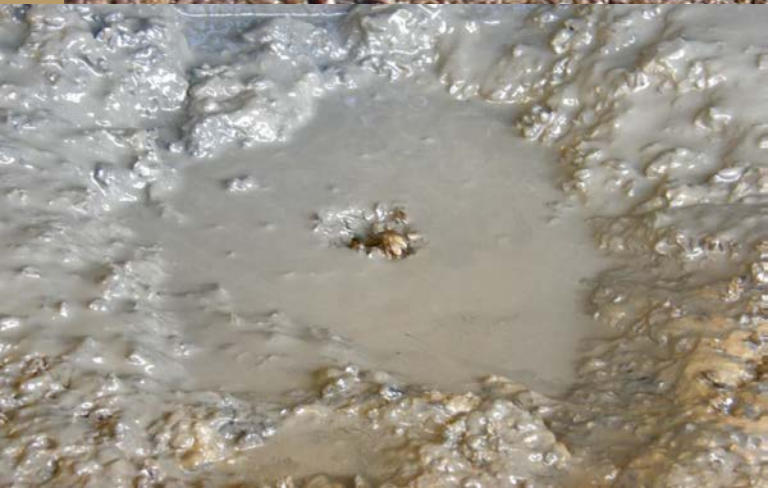
Davis Dam Fixed Wheel Gate - Oct 07

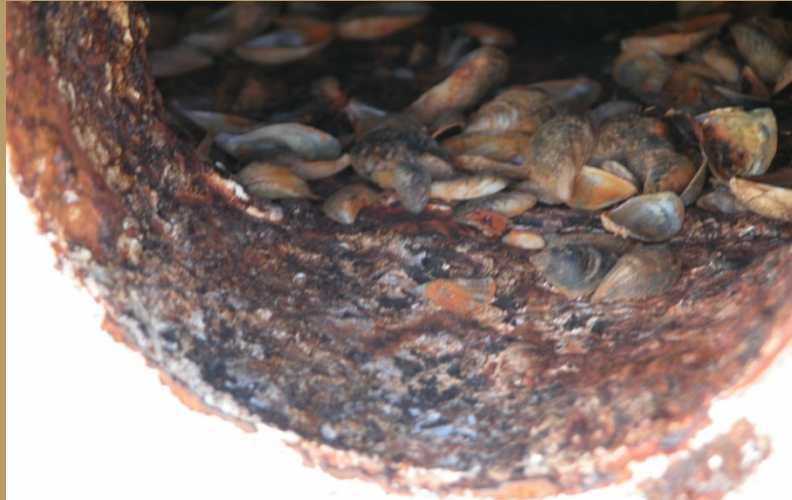
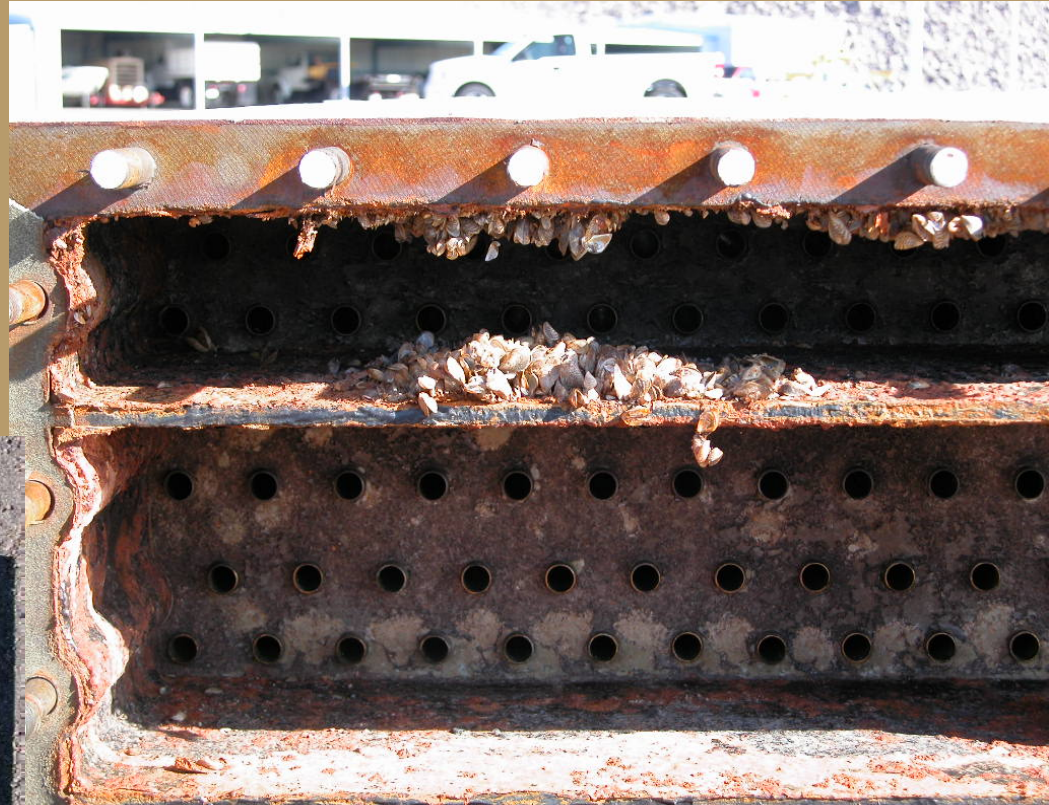
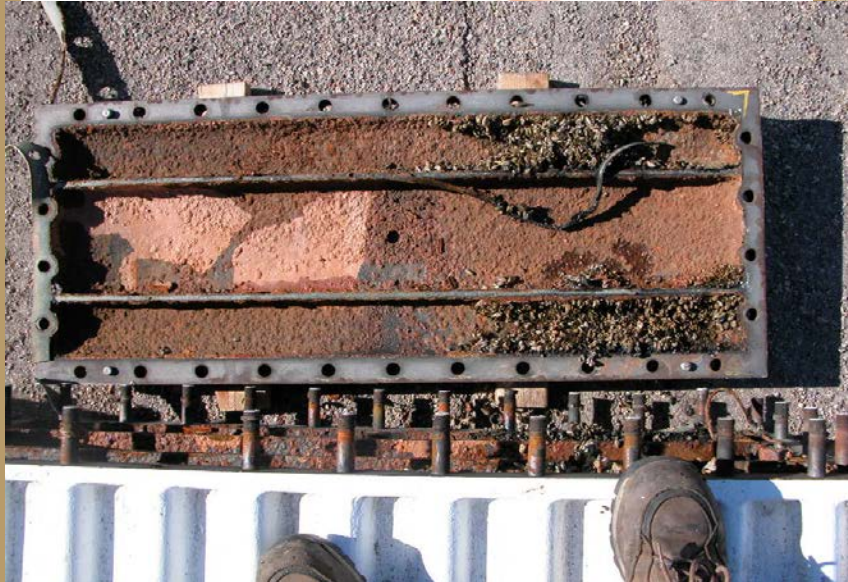
Generator Cooling Water Heat Exchanger Davis Dam - Dec 2009

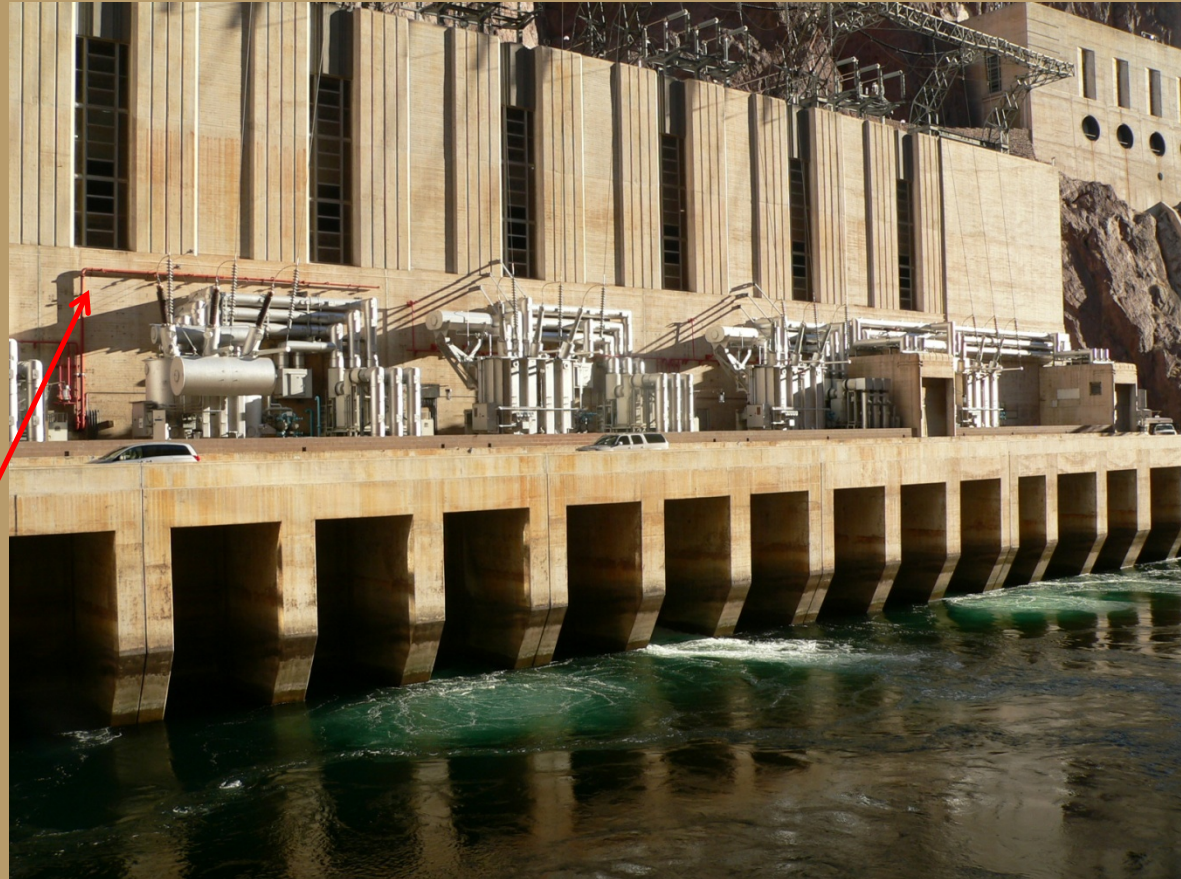
Fire protection and other cooling water systems need protection

**Transformer
cooling water**

Fire nozzles

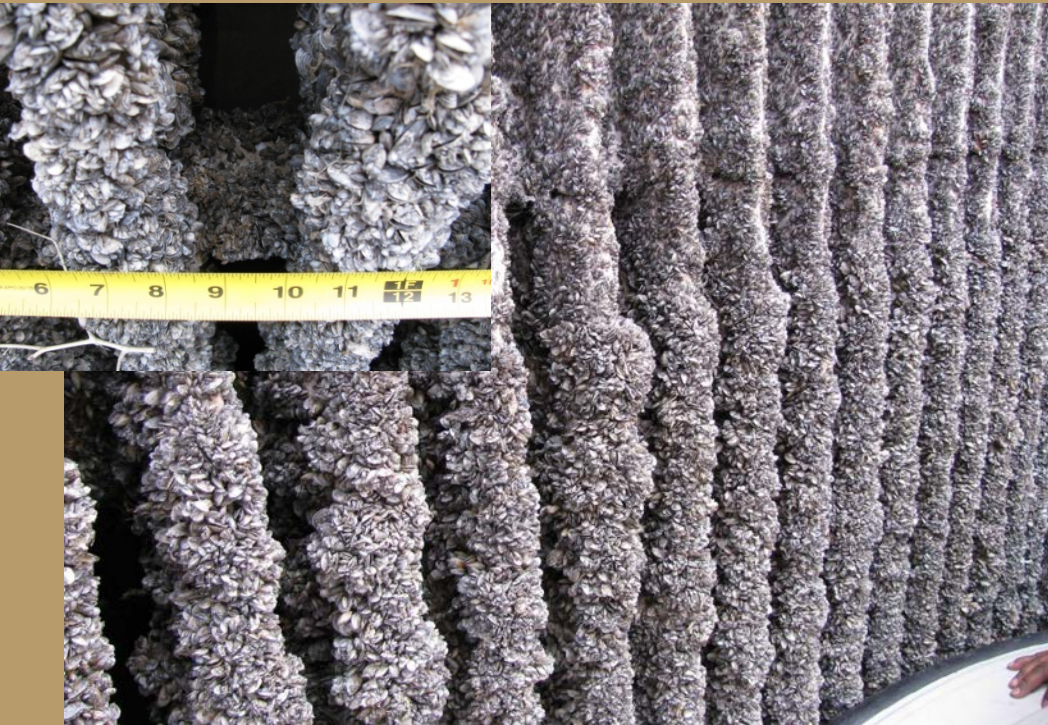
Intake Towers - April 2009

**Trash Racks
6/2009**

**Upper
Cylinder Gate
11/2007**

**Fore bay
1094 ft**

**Intake -
1045 ft**

**Intake -
895 ft**

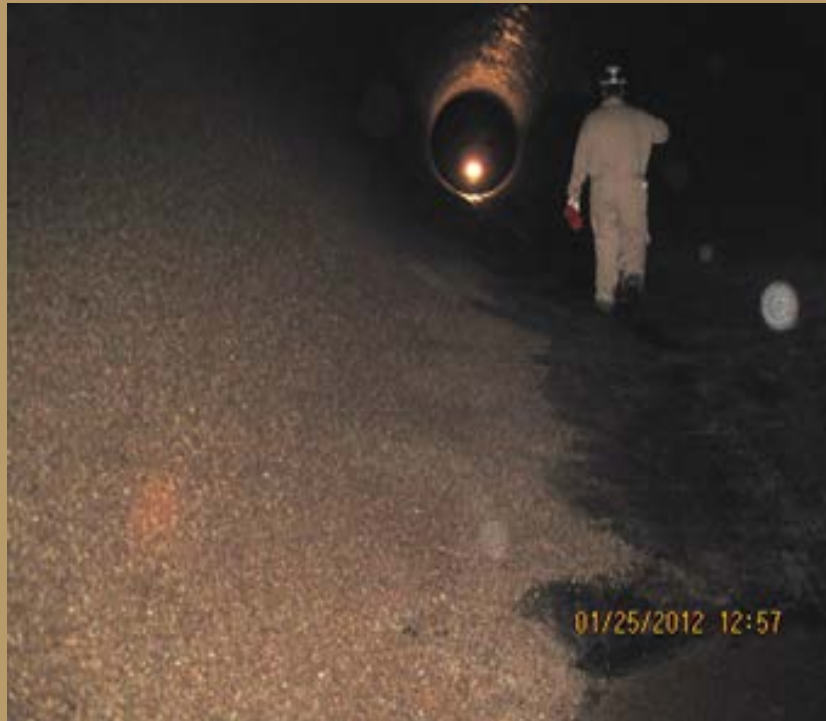
Mussel Shell Debris in Penstock serving Multiple Laterals

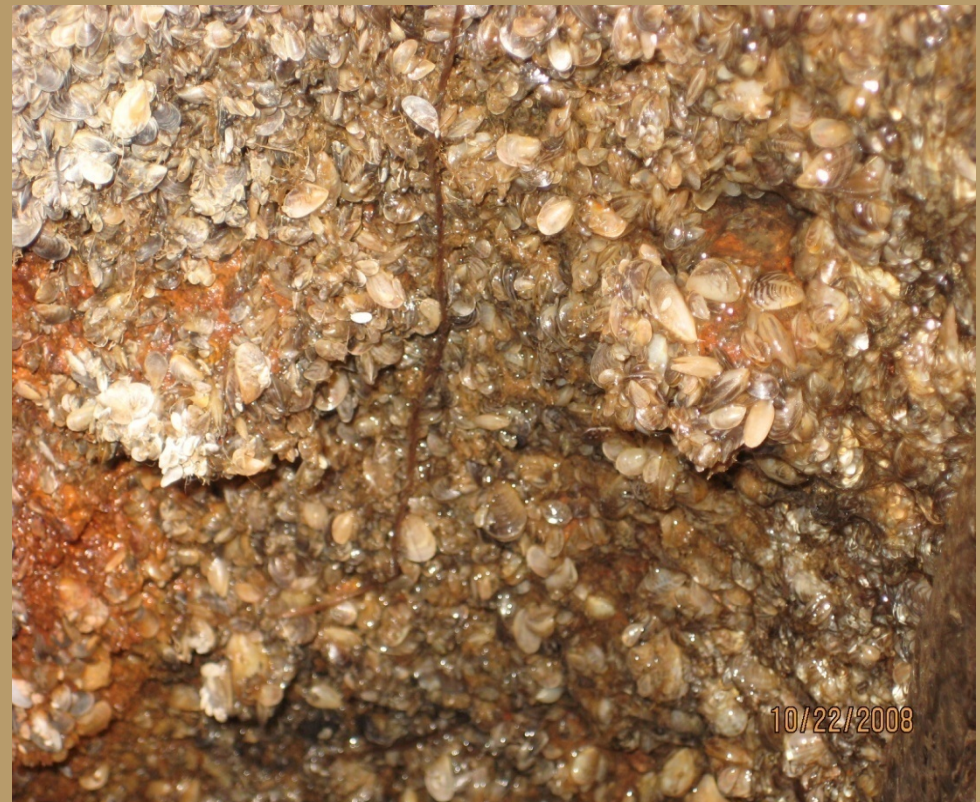
Penstock Drain – Heavy Settling

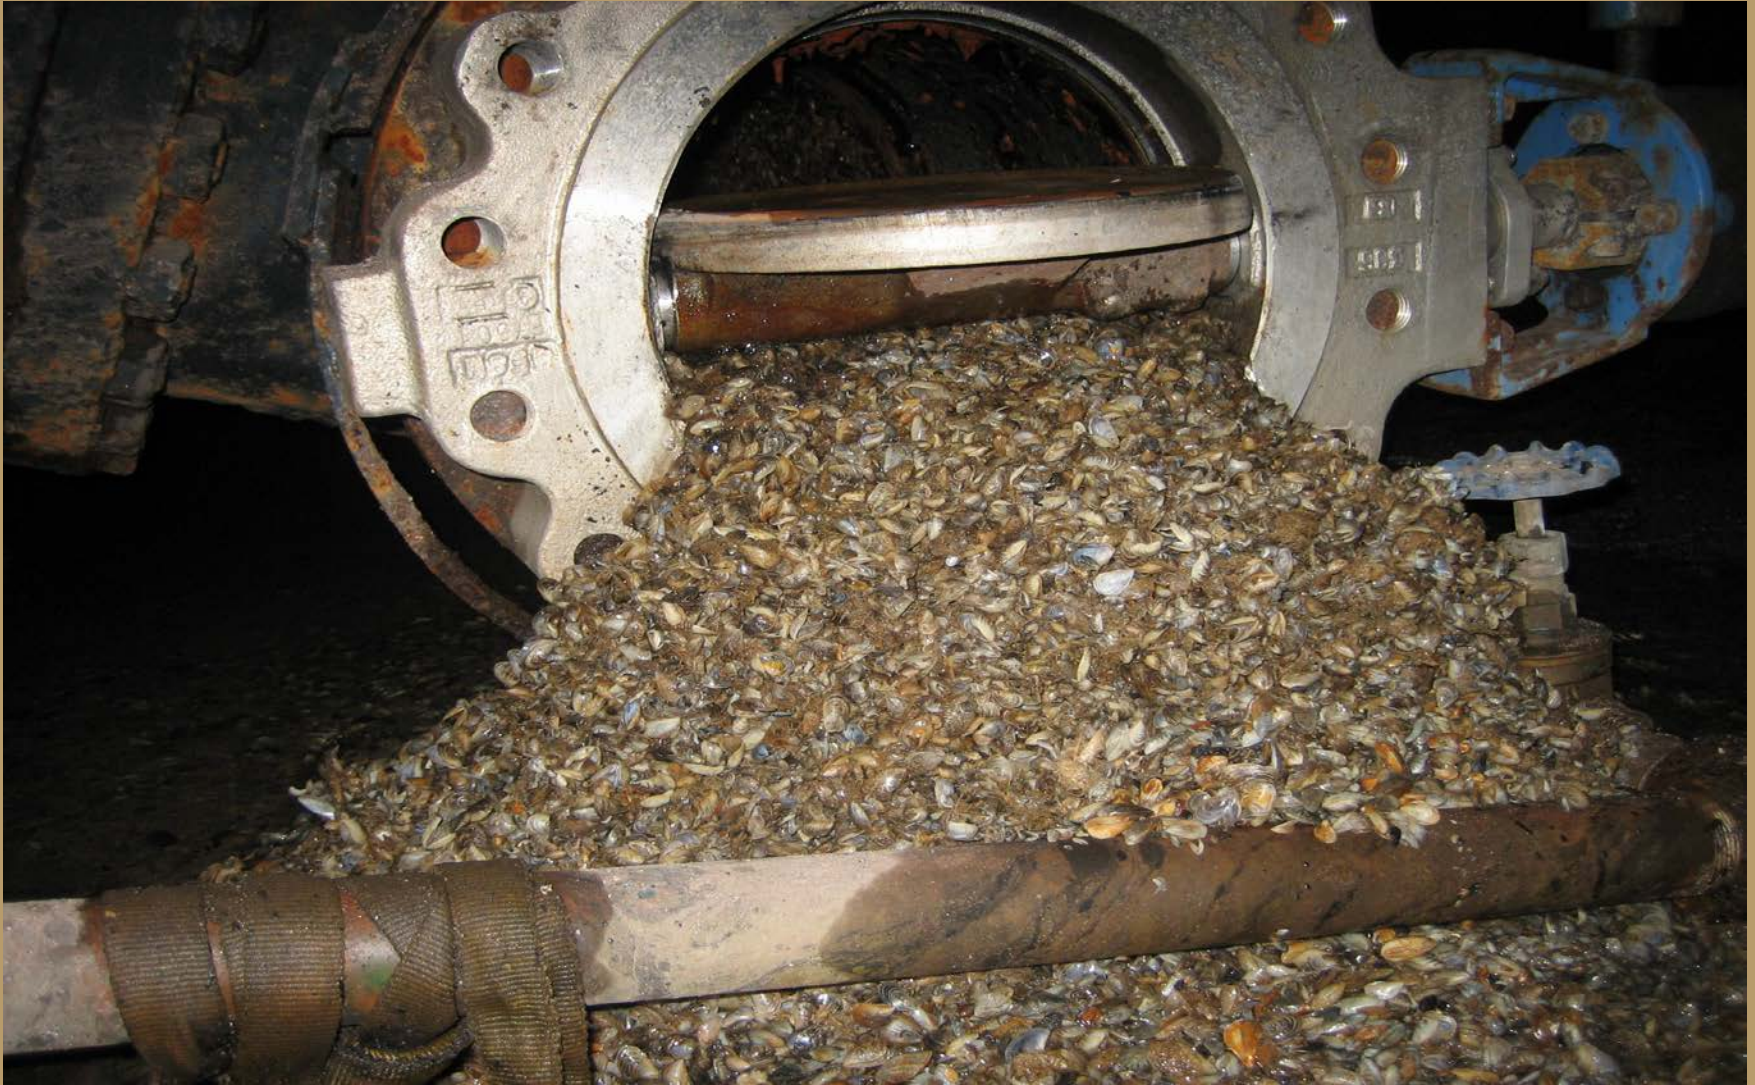
Penstock belly drain – Oct 2010

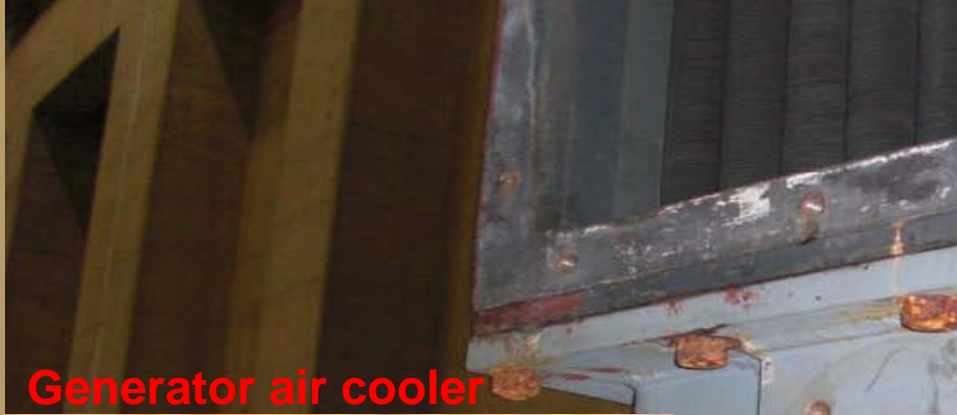
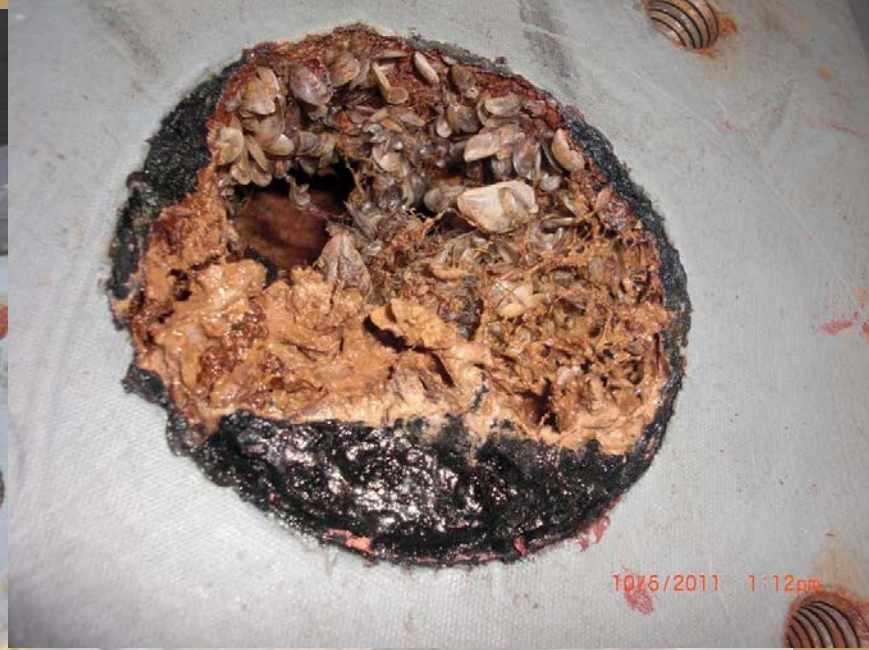
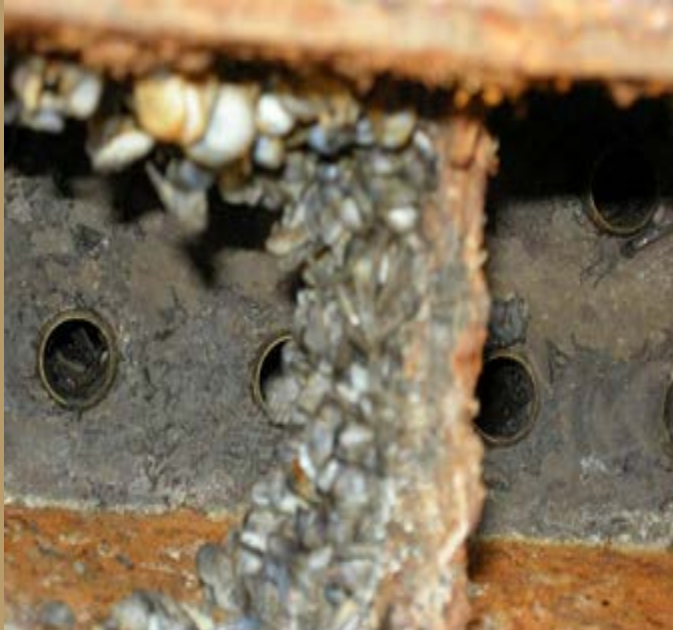
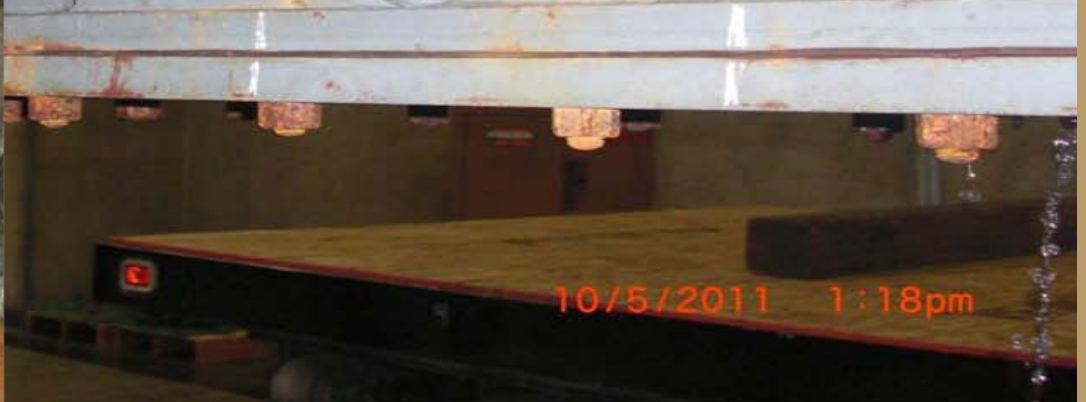
Clogged generator air cooler connection

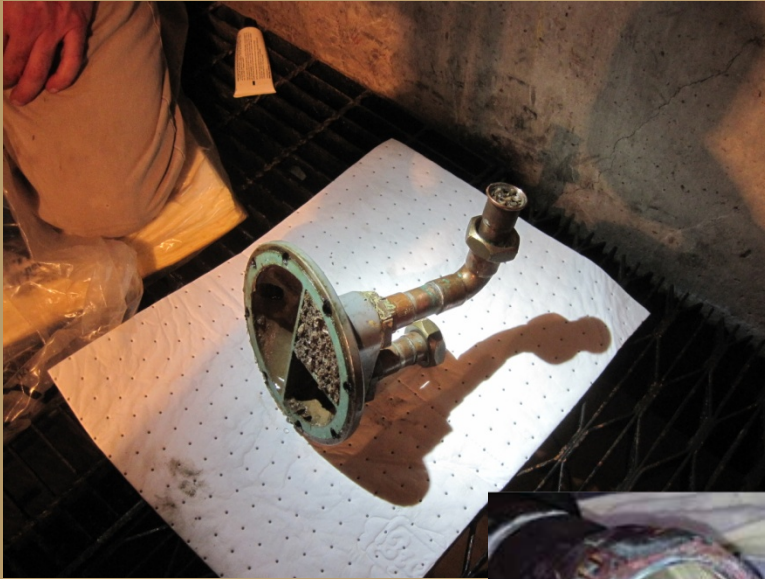
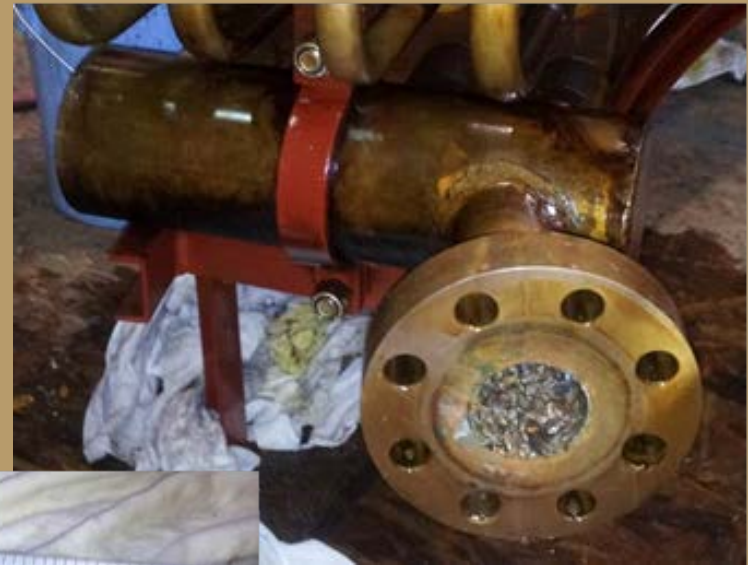
Shell Debris - Oil and Bearing Coolers

Shell debris from thrust bearing cooler piping

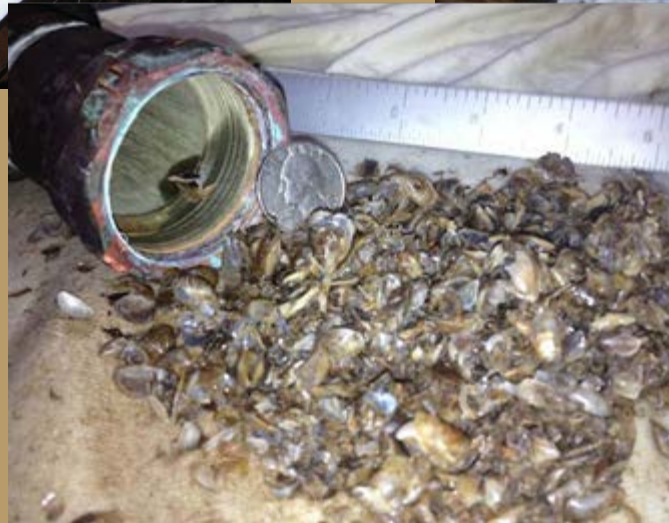
Clogged thrust bearing cooler

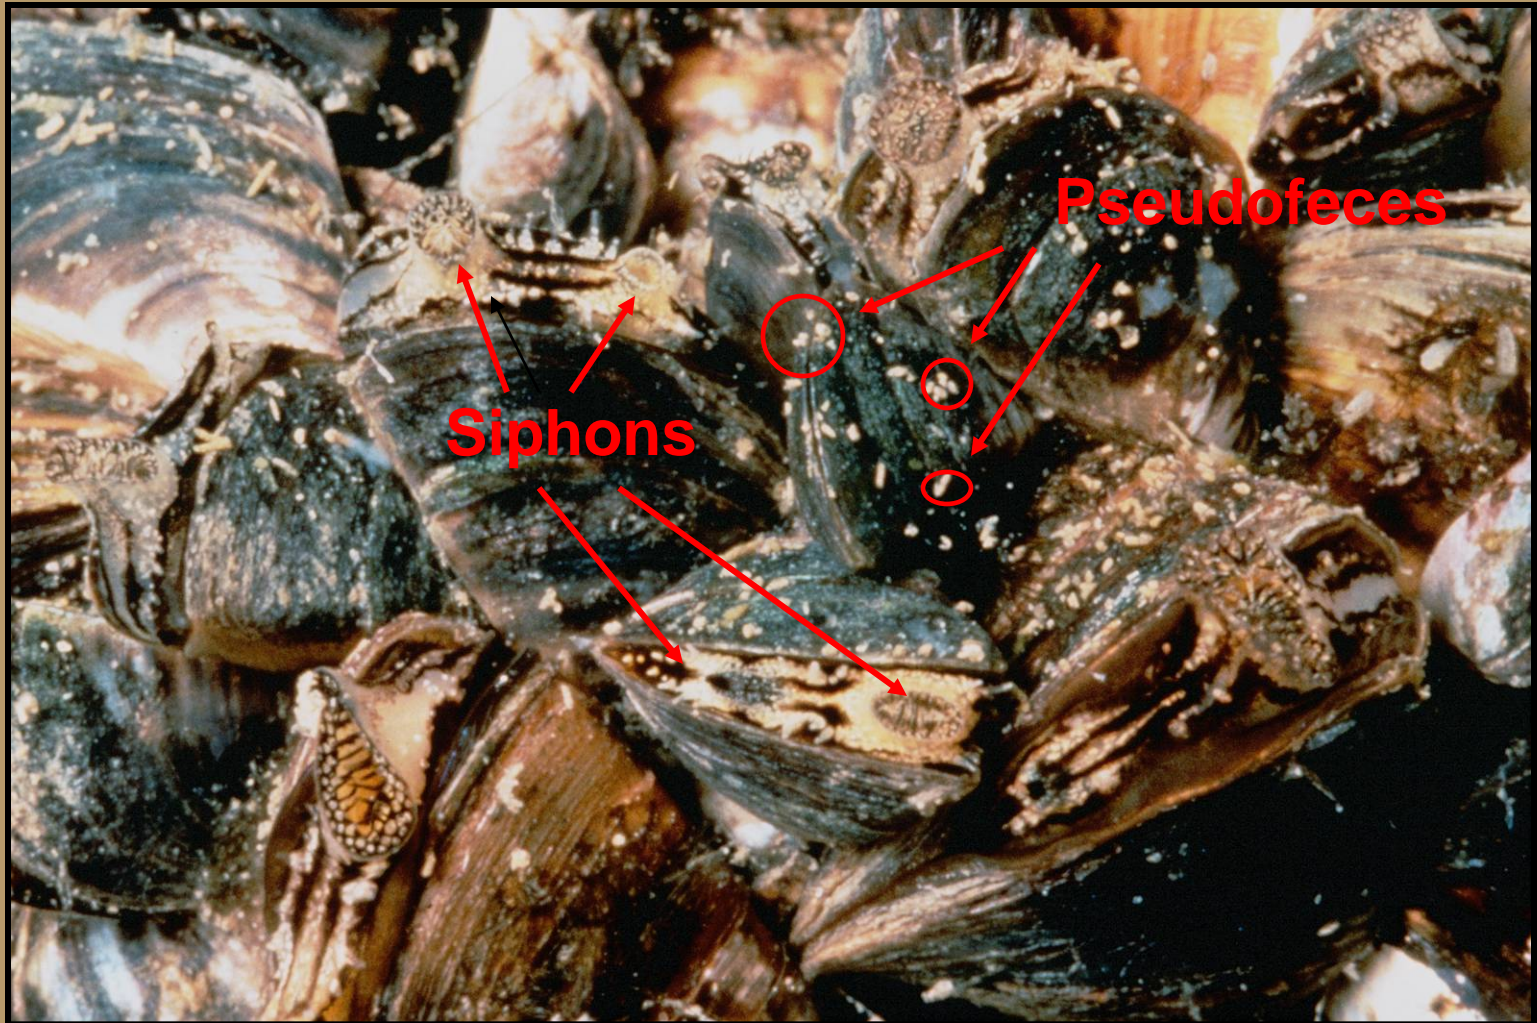
Chemical Degradation - Corrosion
