Taking No Prisoners Beating Back Invasive Species

**Leonard Willett - Lower Colorado Region
Renata Claudi – RNT Consulting Inc.**

U.S. Department of the Interior
Bureau of Reclamation

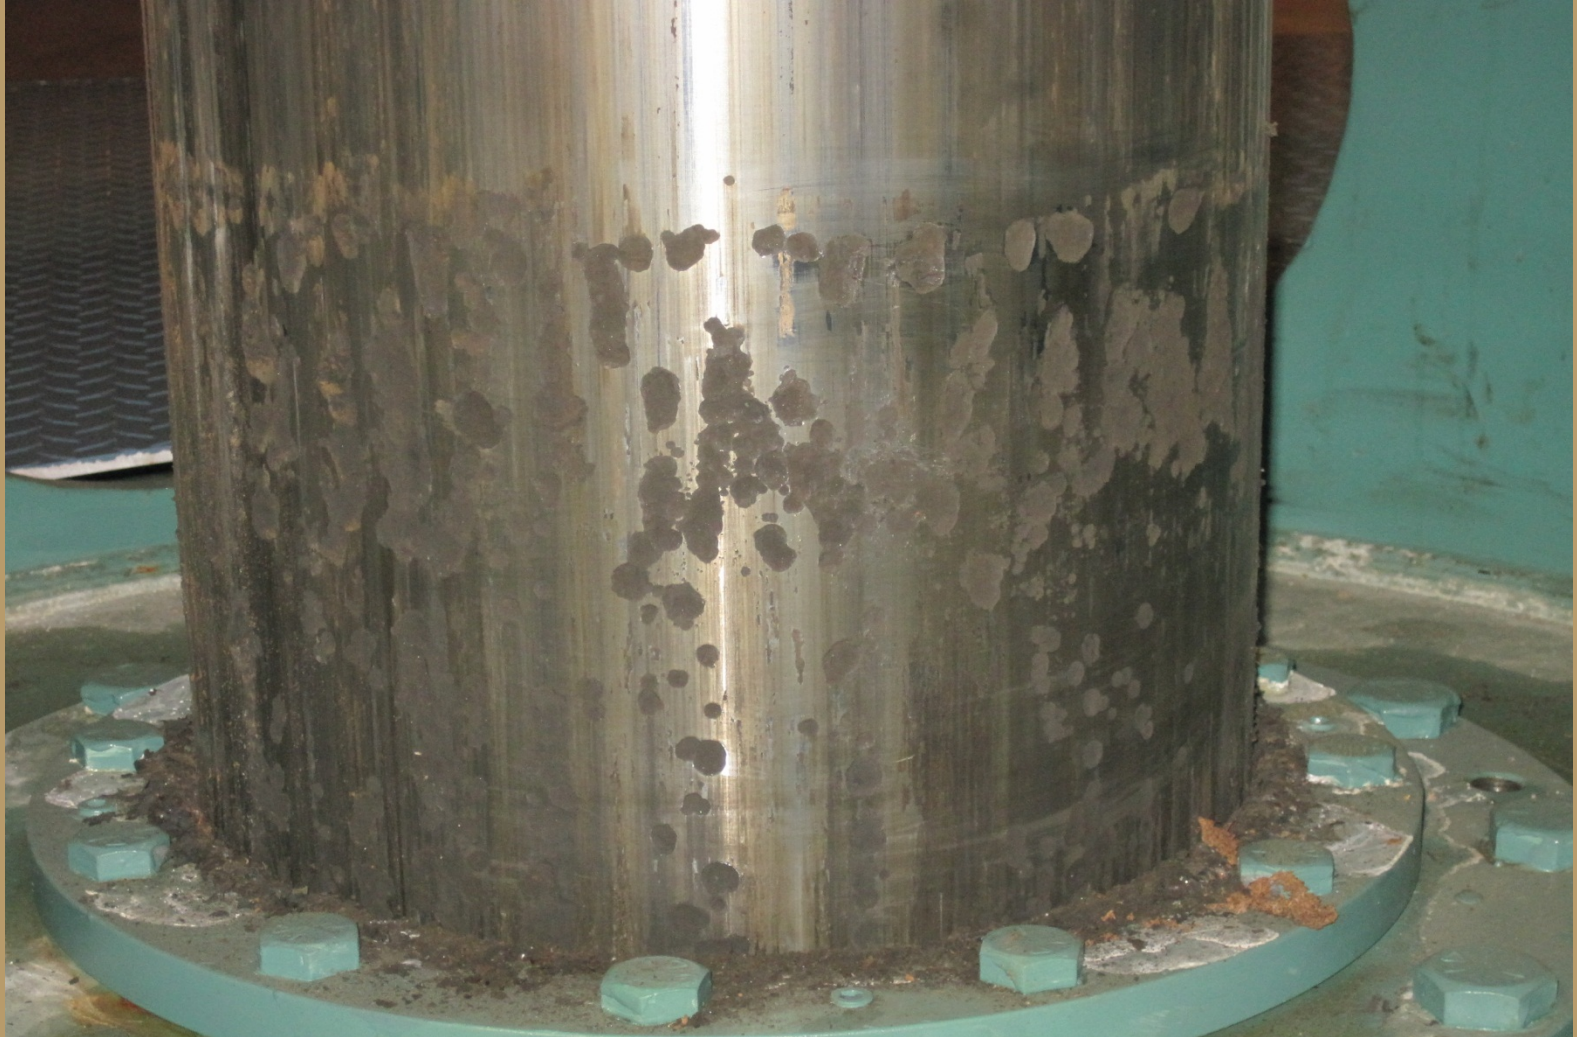
Hoover Dam Pressure Relief Valve Shaft Corrosion – April 2013

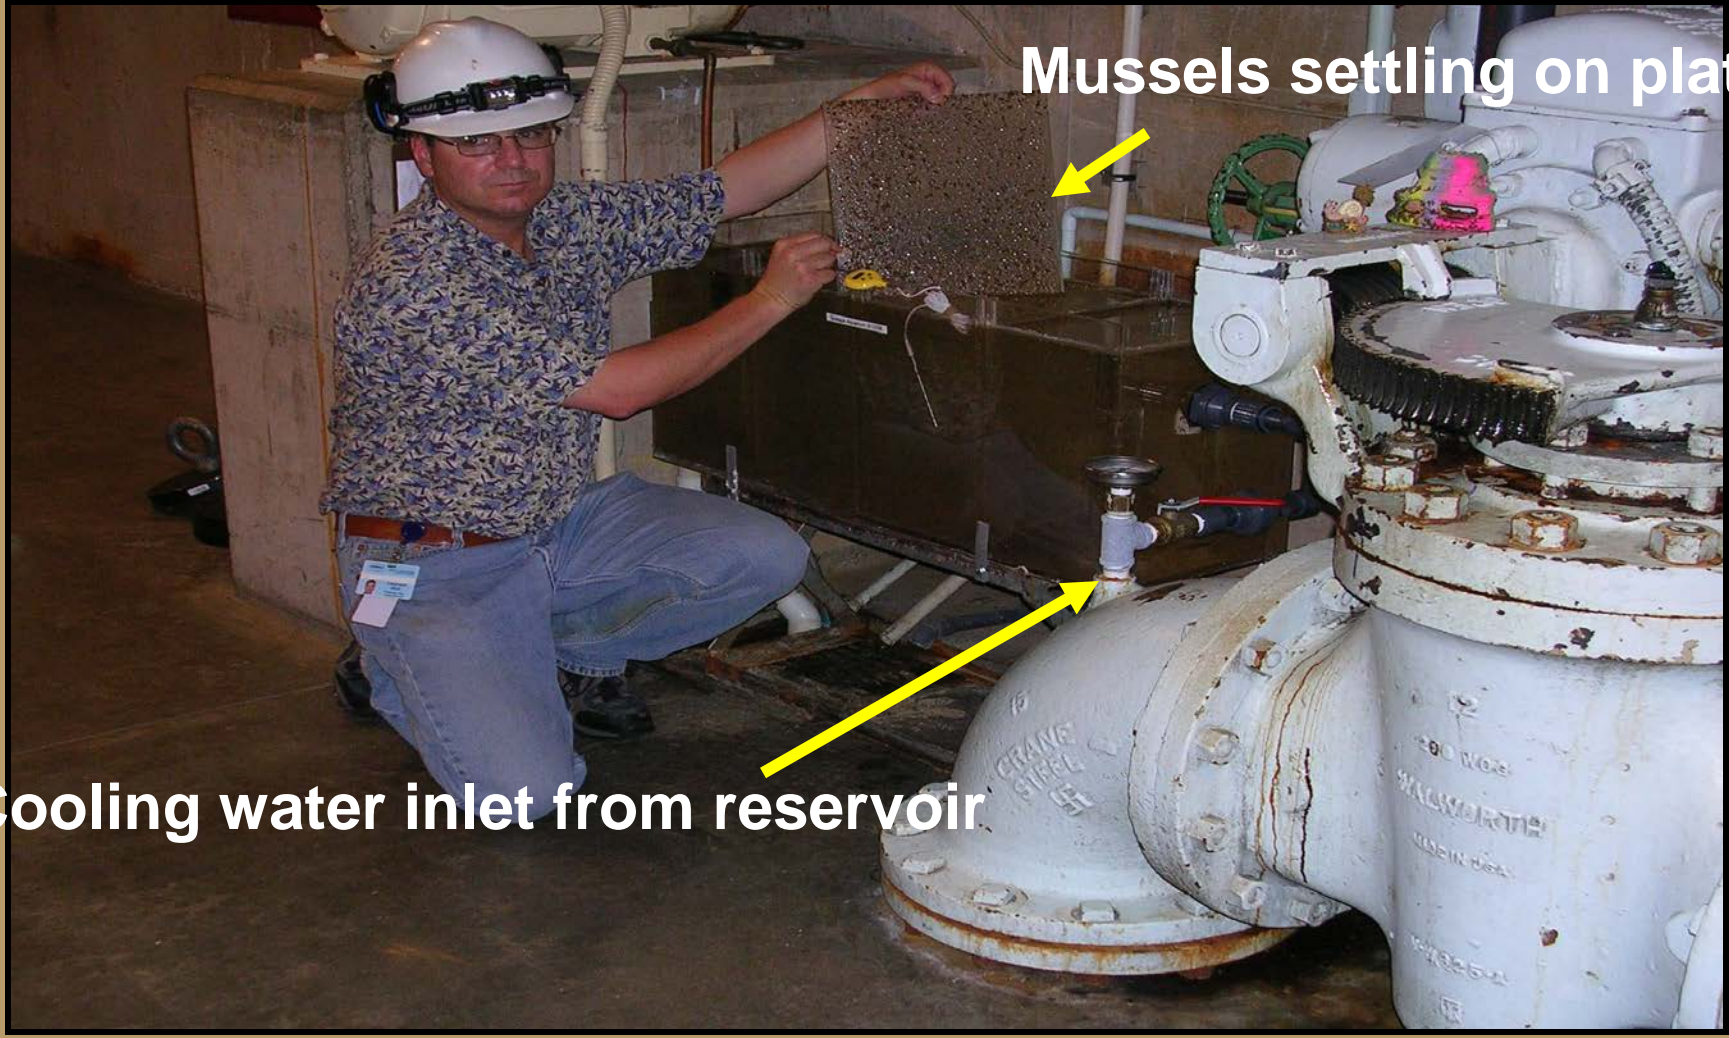
Installed Bio-Box Sampler for Monitoring

Mussels settling on plates

Cooling water inlet from reservoir

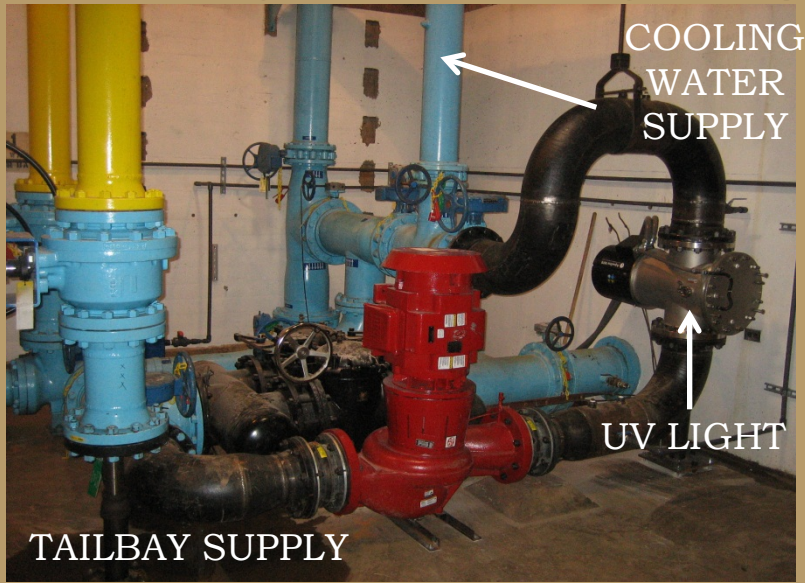
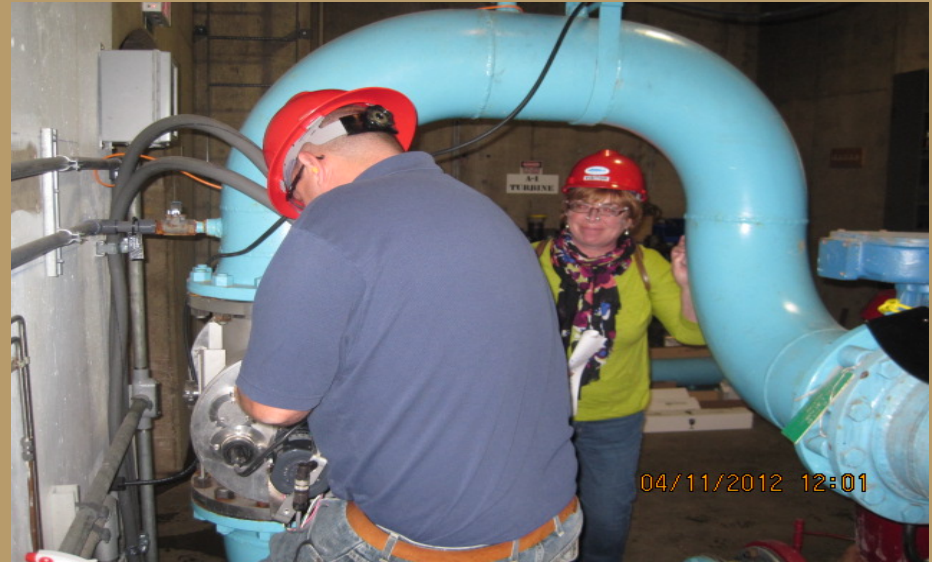
Hoover Dam Cooling Water Mussel Control UV System (research)

Started August 2010
2 lamps

Renata Claudi (RNT Consulting)
starting 4 lamp evaluation

Upgrade to 4 lamps to increase
dosage April 2011

No mussel settlement downstream of UV Lights at Dose of approx. 130 mj/cm²

- The UV system set to accommodate maximum flow rate and minimum UVT of water
- Dose had to be kept at a maximum to guarantee success

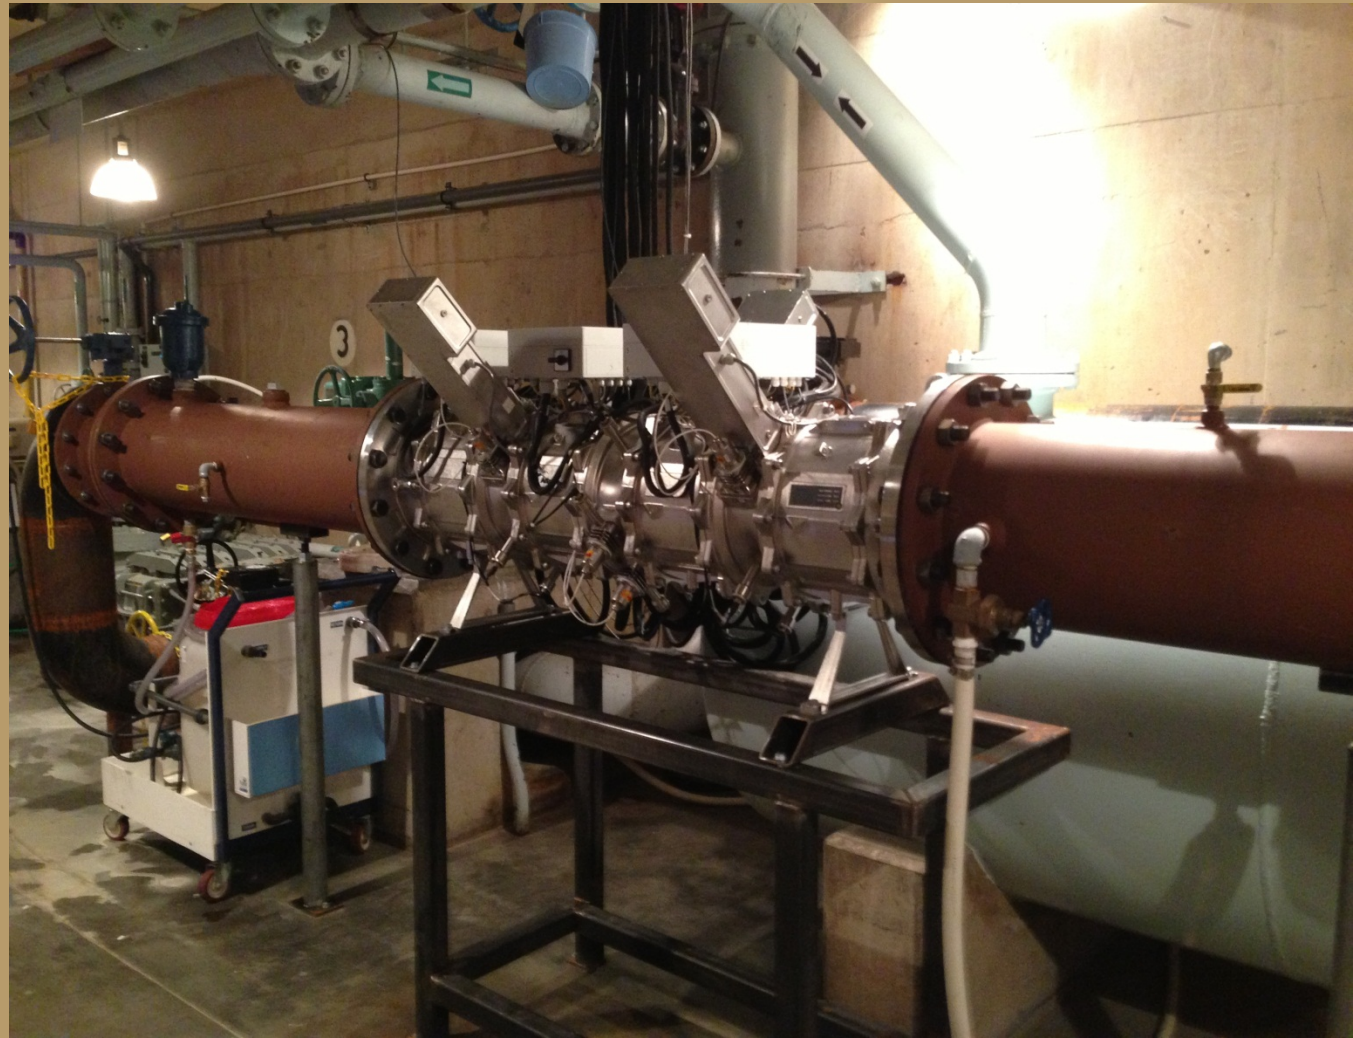
Power Plant Mussel Control System Atlantium (HOD) UV Light System

UV Cooling Water System
installed July 2013 on a
4000 GPM system

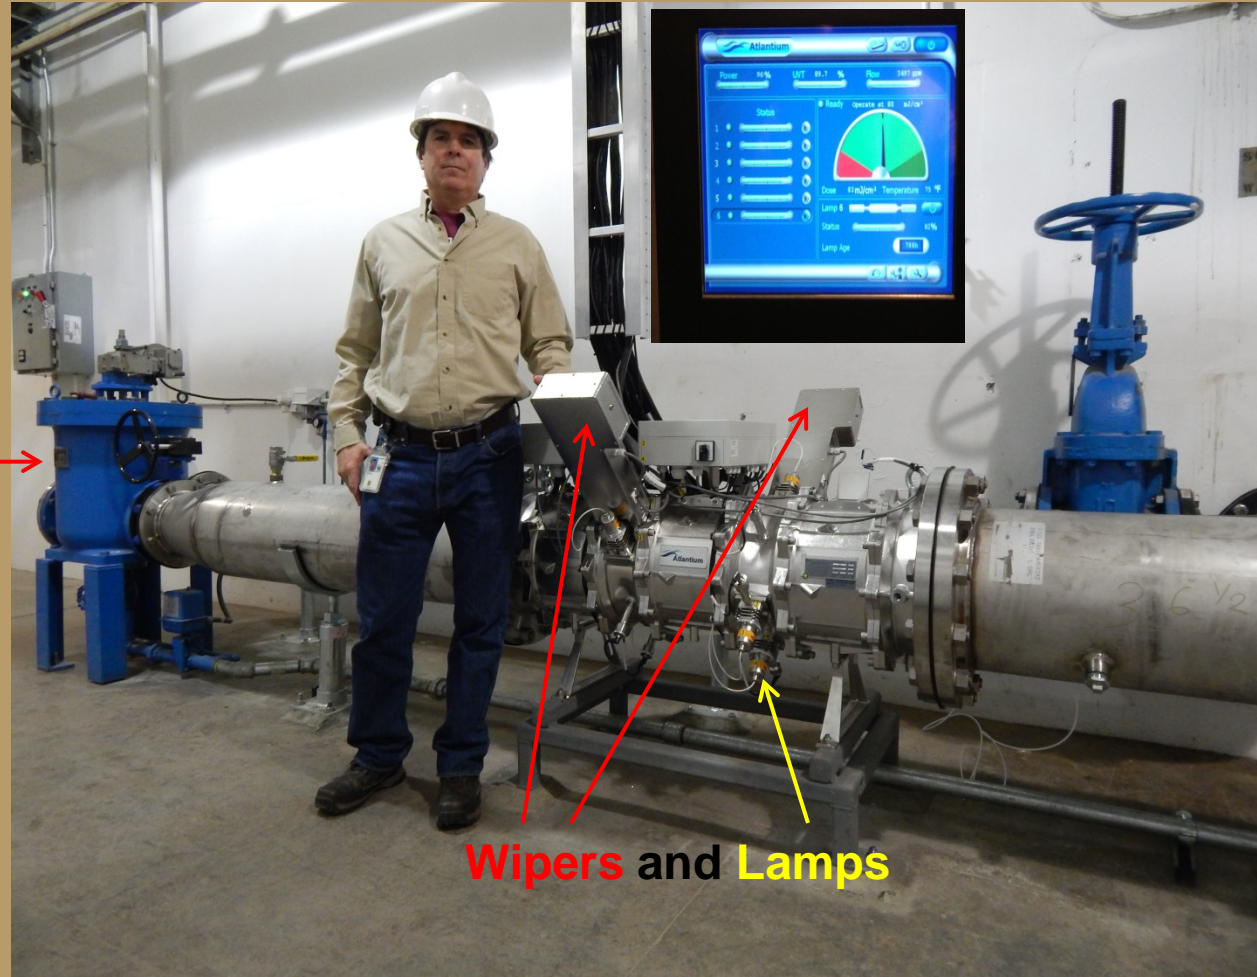
Power Plant Parker Dam Mussel Control System Atlantium (HOD) UV Light System

UV Cooling Water System installed Nov. 2015 on cooling water of each of The four units (1600 GPM) As well as the domestic water supply line

Self Cleaning Strainer →

Wipers and Lamps

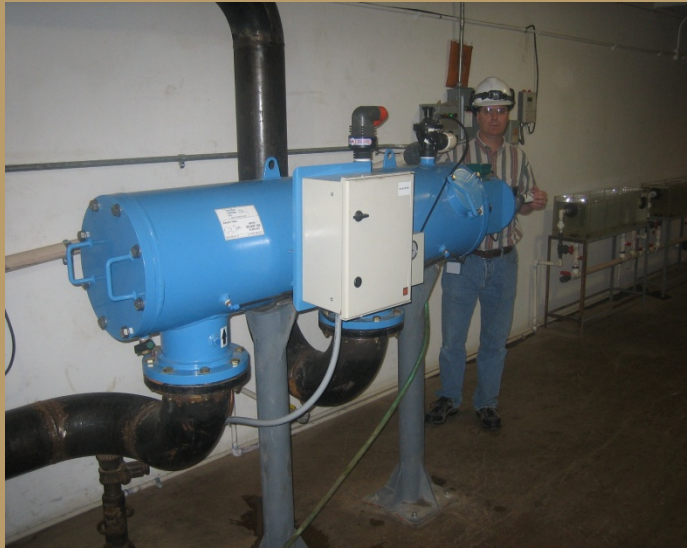
40 & 80 micron filter
cartridge inside of all
housing

Parker Dam
Research Filter
2008 - \$100K

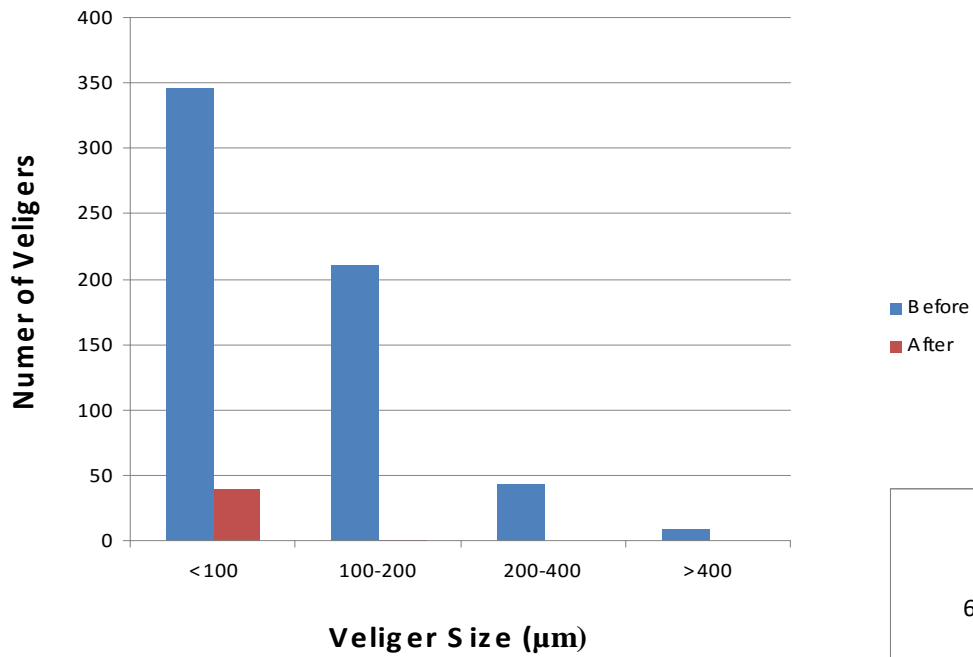
40 Micron Filter Tests

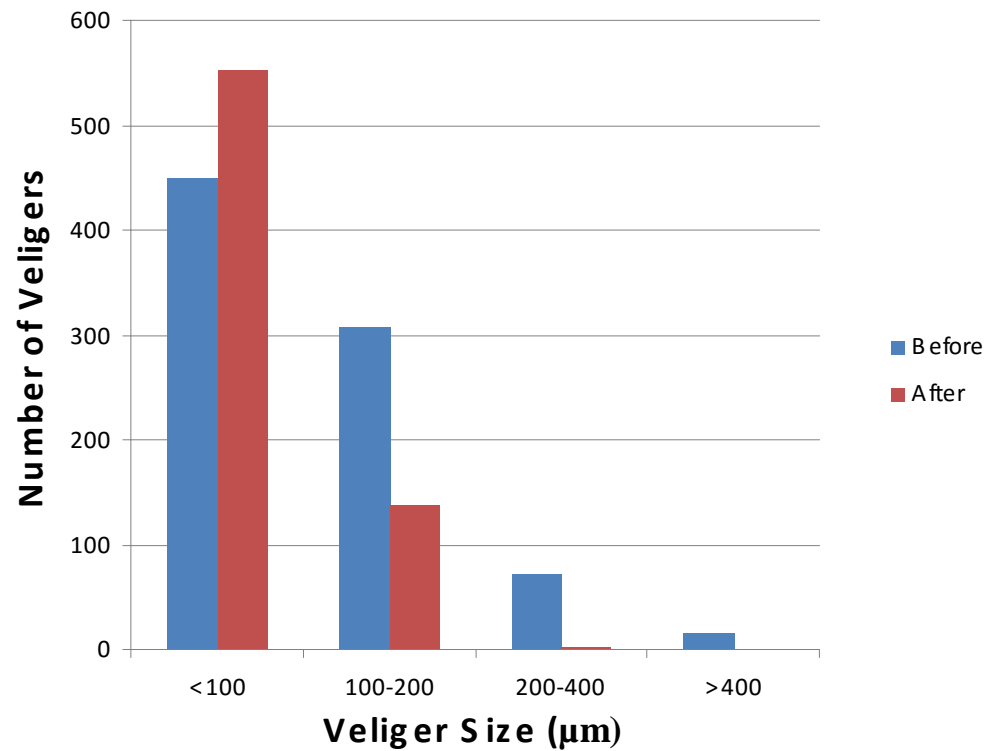
80 Micron Filter Tests

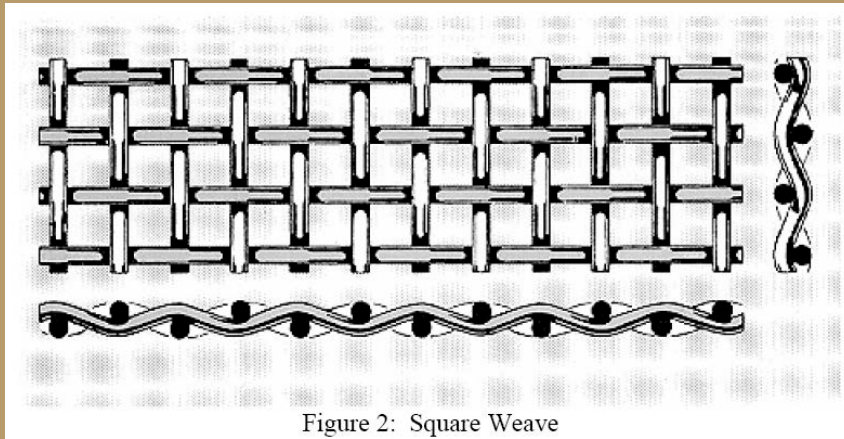
Figure 2: Square Weave

Square Weave Mesh is Essential

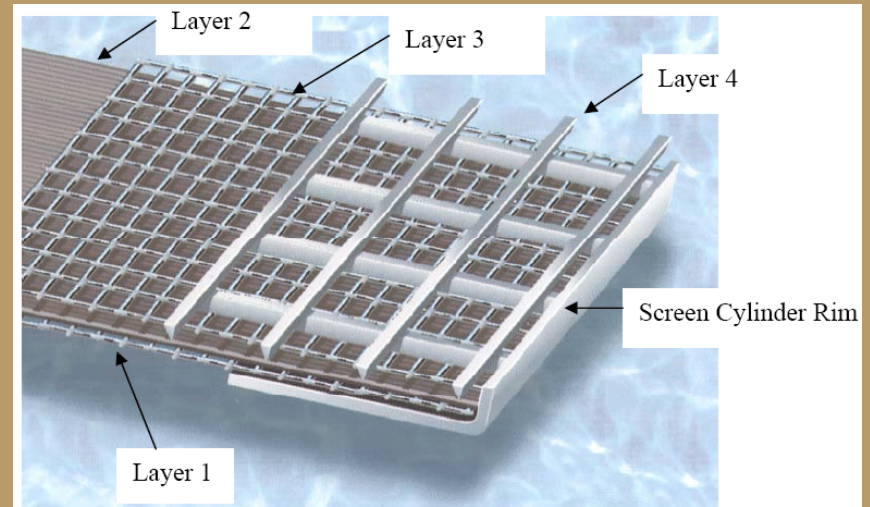
Figure 4: Patented Four-layer Screen

Robust Support of the Mesh is Critical

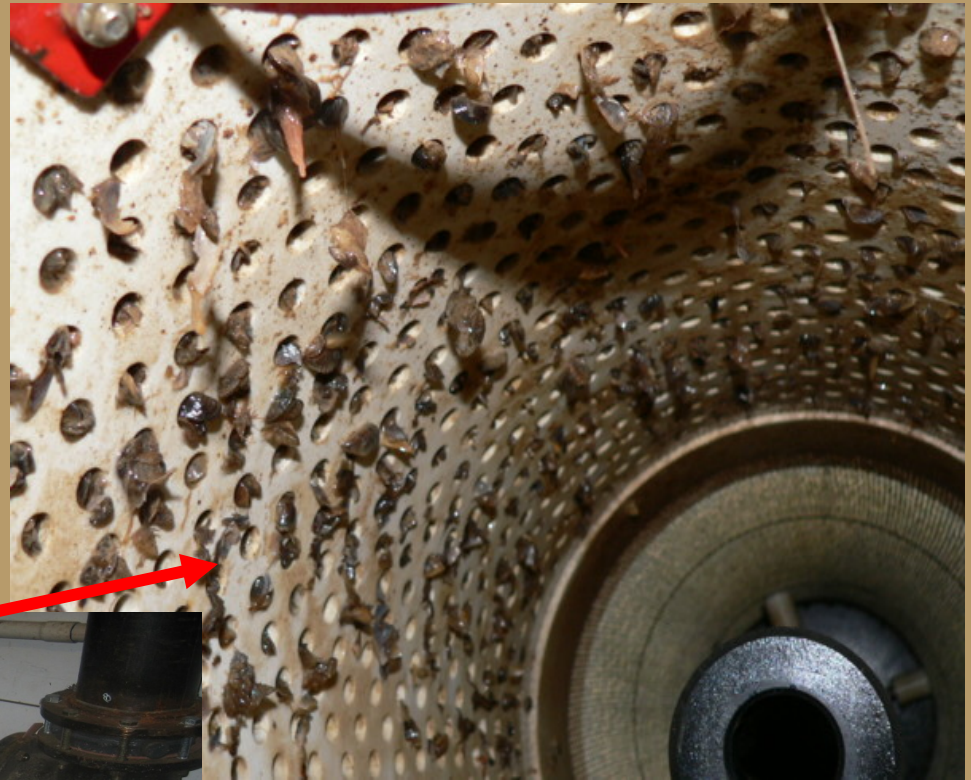
Self Cleaning Ballast Safe Filter

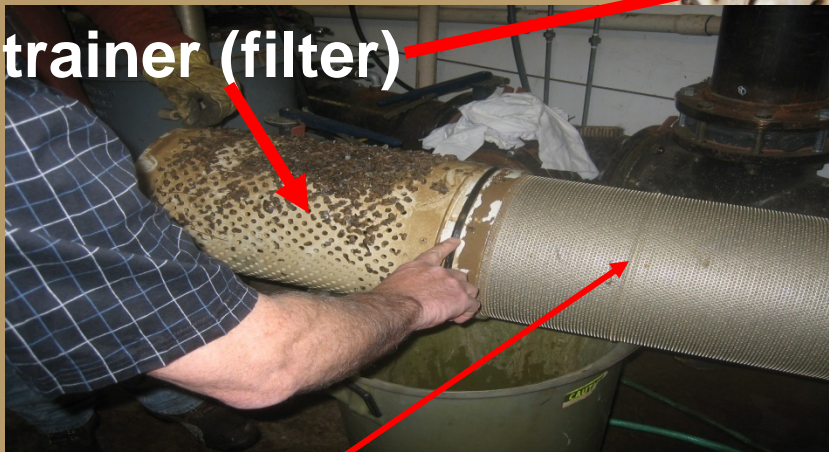
Pre-strainer (filter)

Filter Cartridge – 40 micron

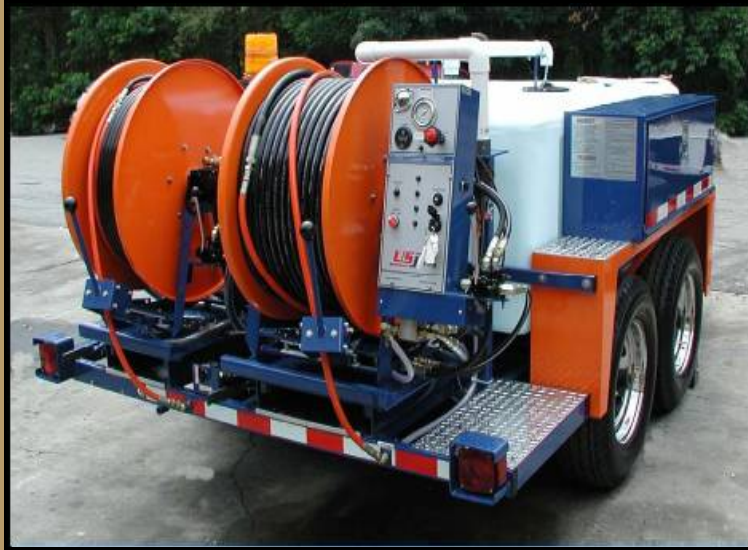
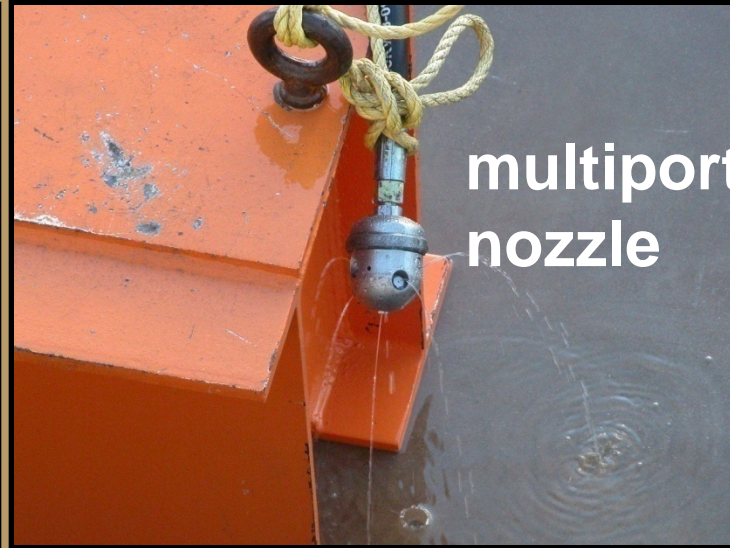
Water Jetting Equipment

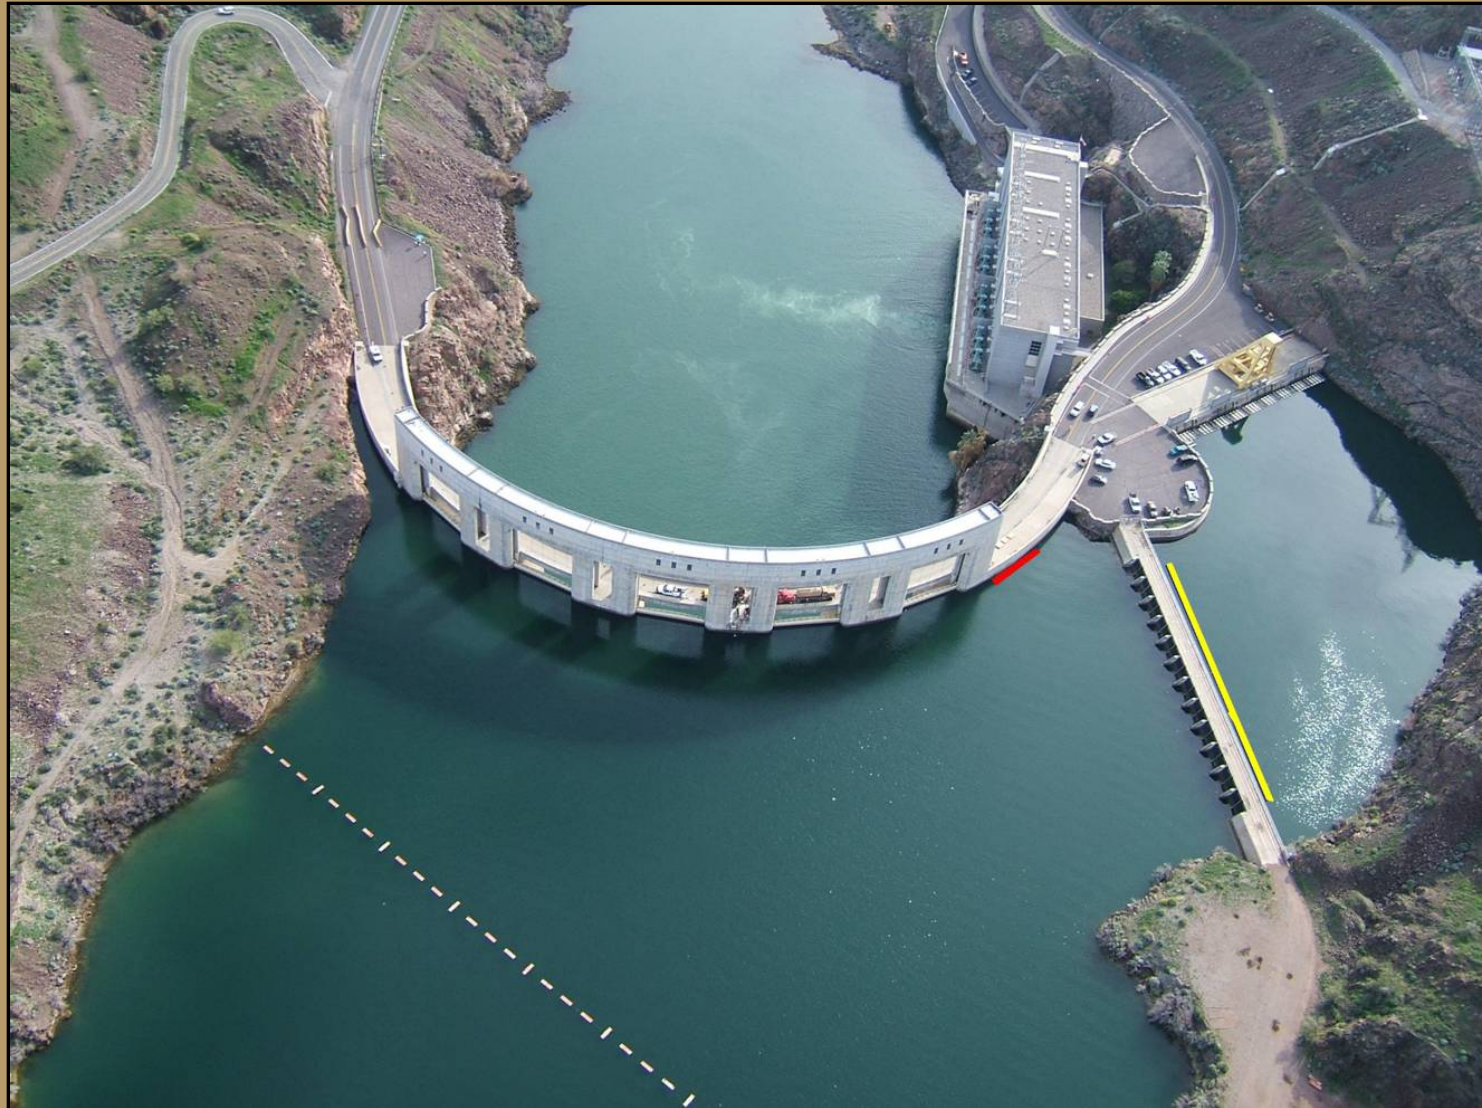
Coatings Panels Locations – Parker Dam

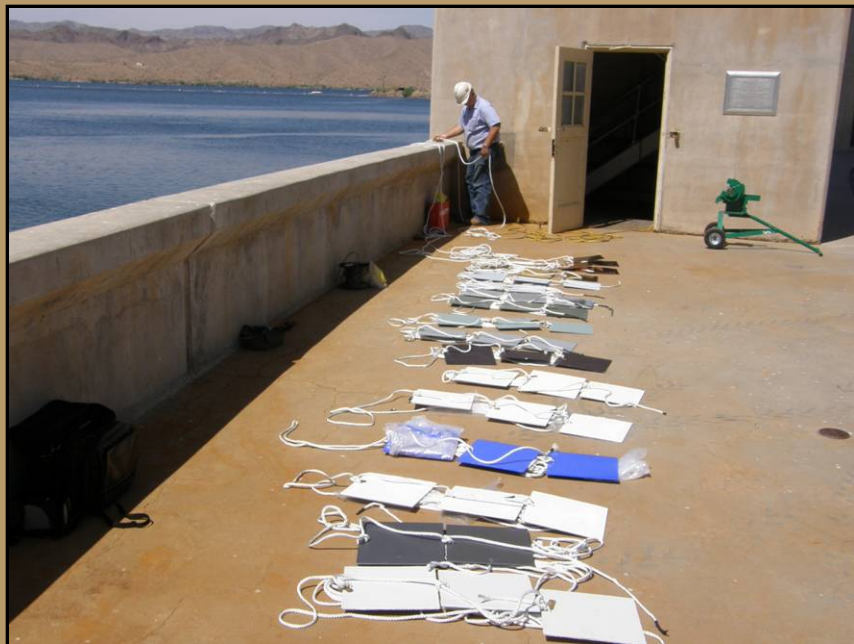
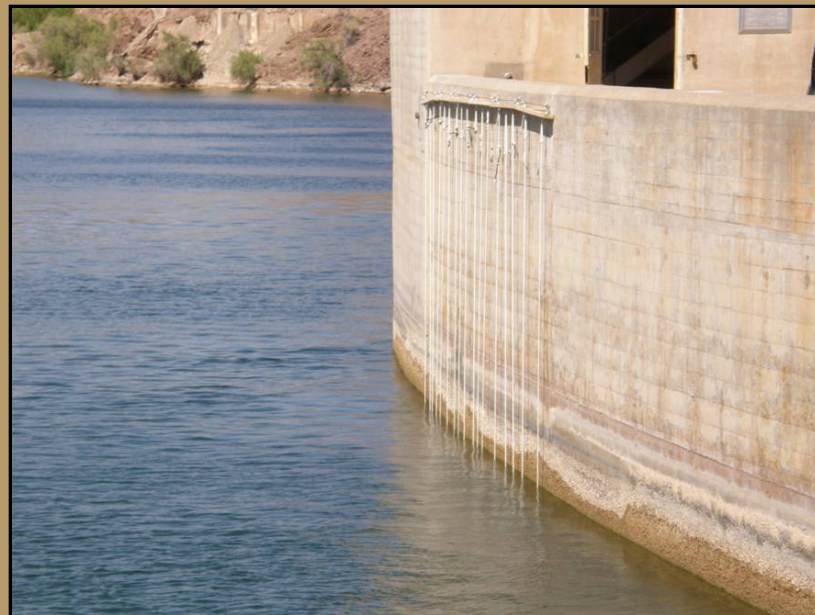
Coatings Panels

**3-month
fouling
rate**

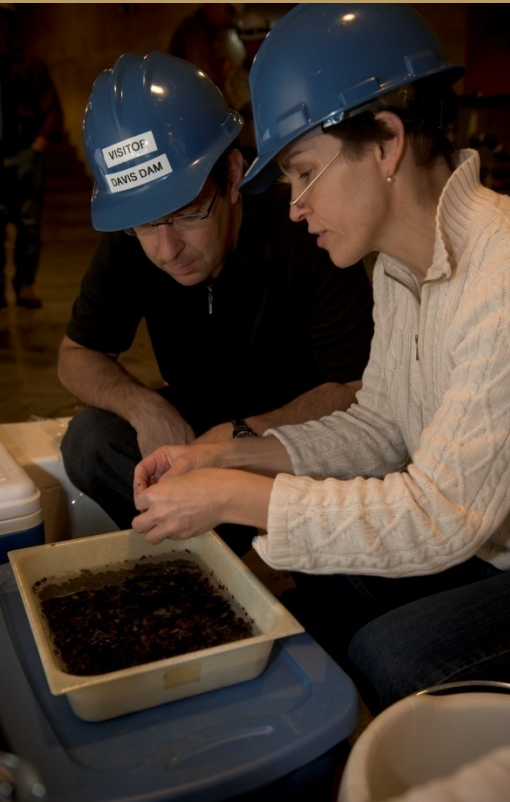
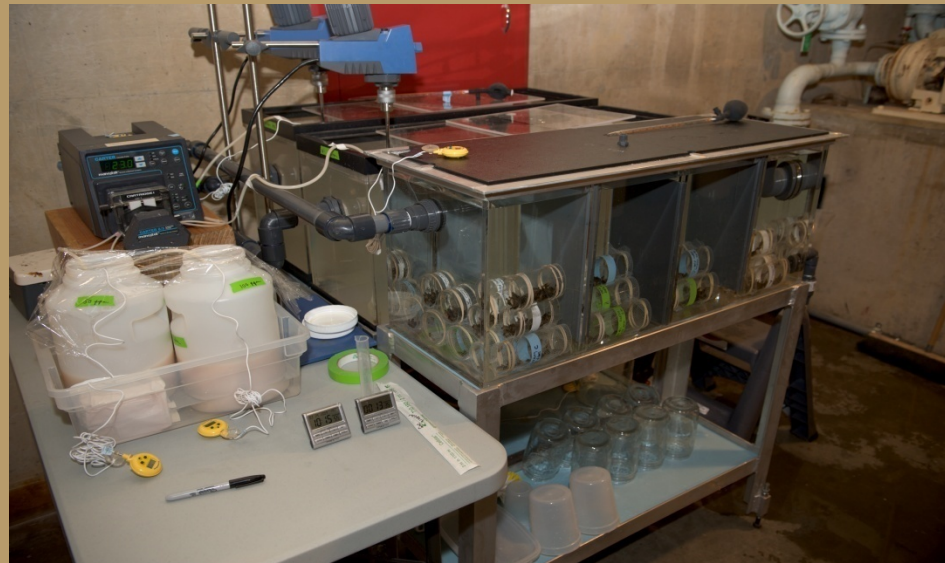
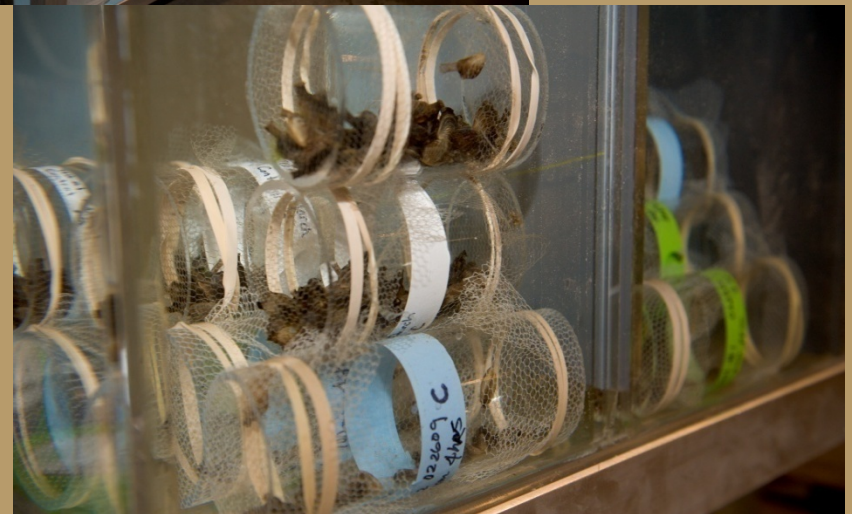
Zequanox Trials Davis Dam – Mar 2009

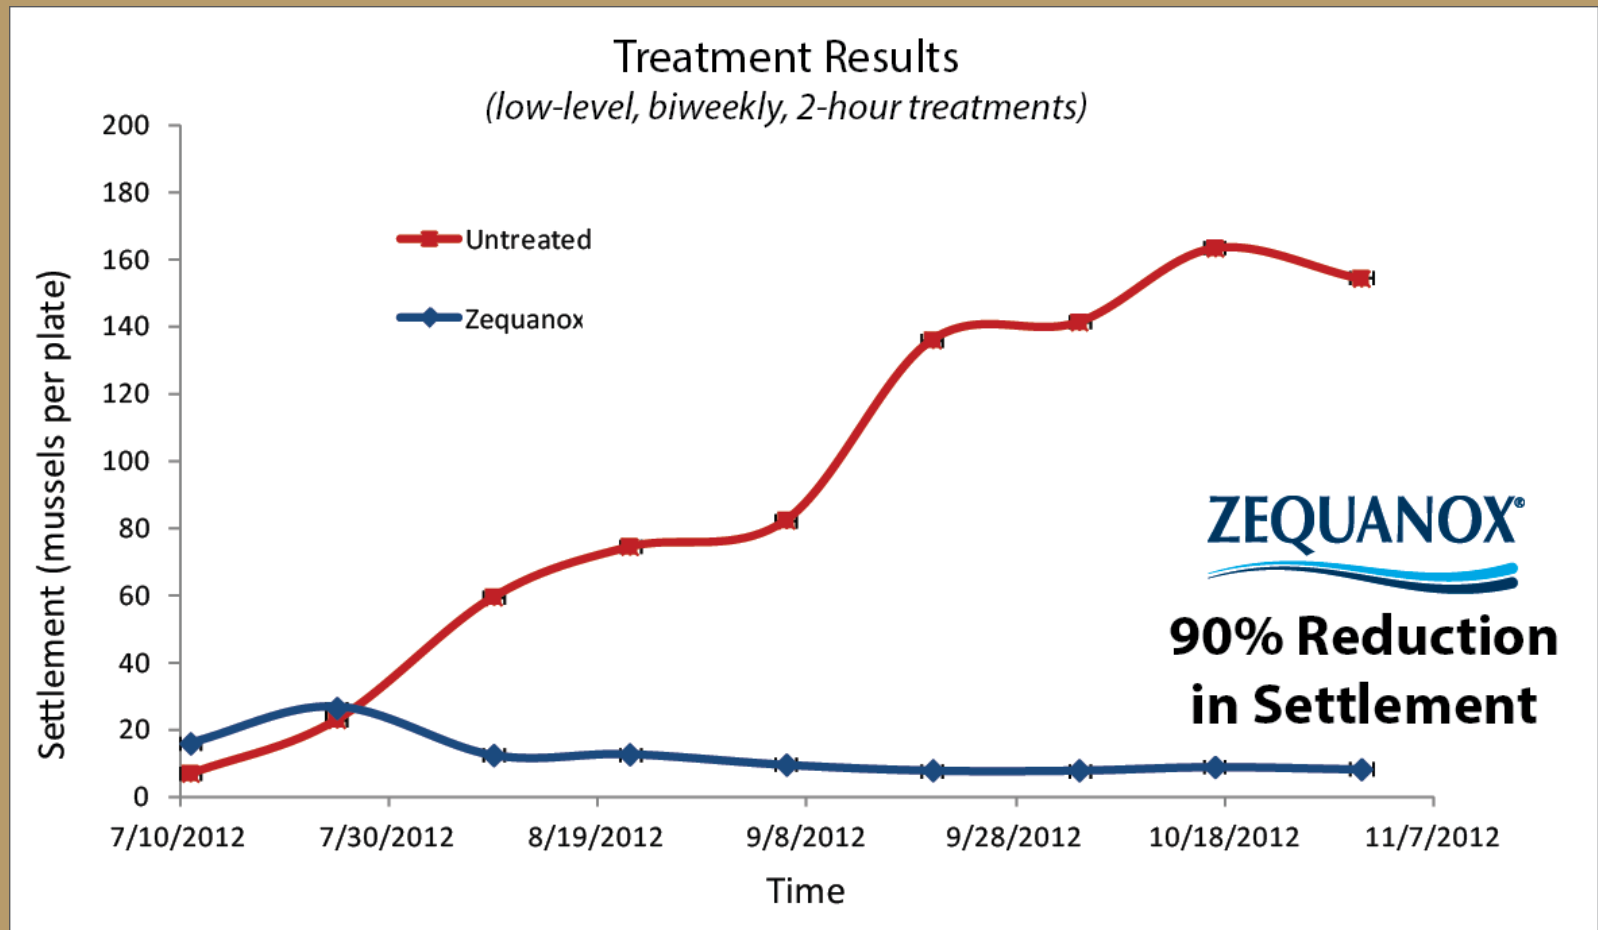
Bi-Weekly Regimen Reduces Settlement by 90%

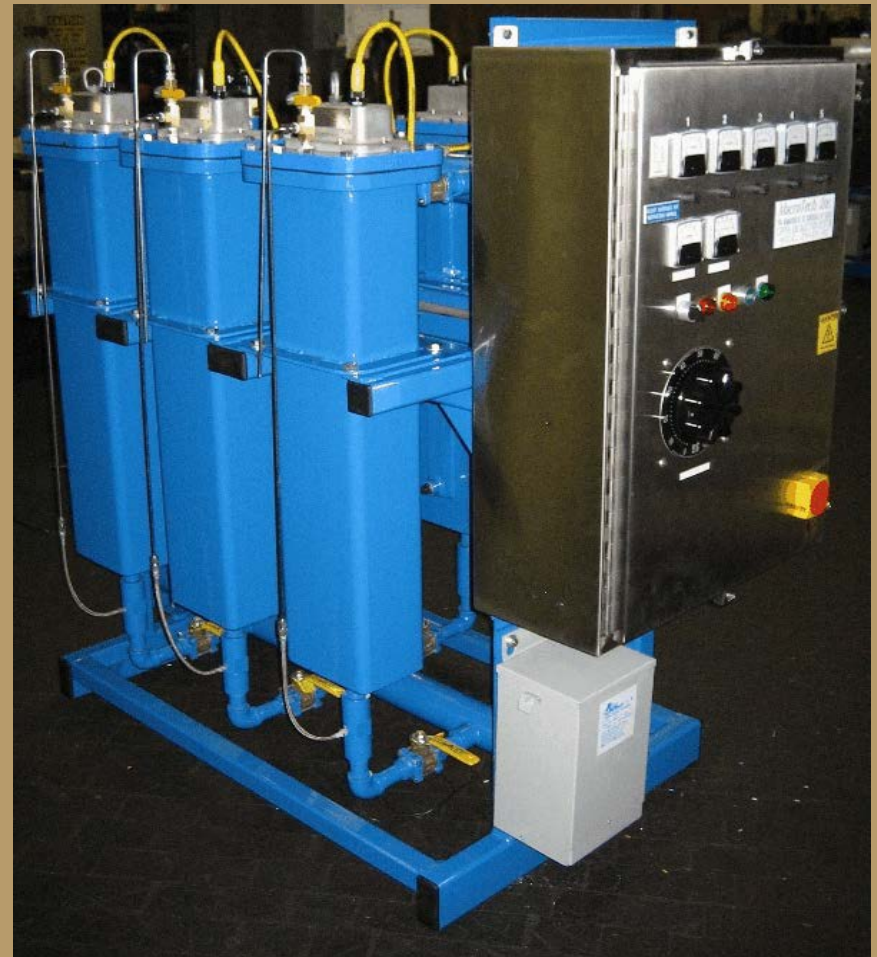
Copper Ion Generator Unit

Anodes and Cathodes are installed in cells (fresh water units). A side-stream of water is passed thru the unit and a copper-rich concentrate is formed. The concentrated solution is then distributed to one or more intakes to treat desired water streams.

Copper is very effective at the ppb level in killing adult mussels and preventing infestation from developing

Significant operational problems with the hardware tested

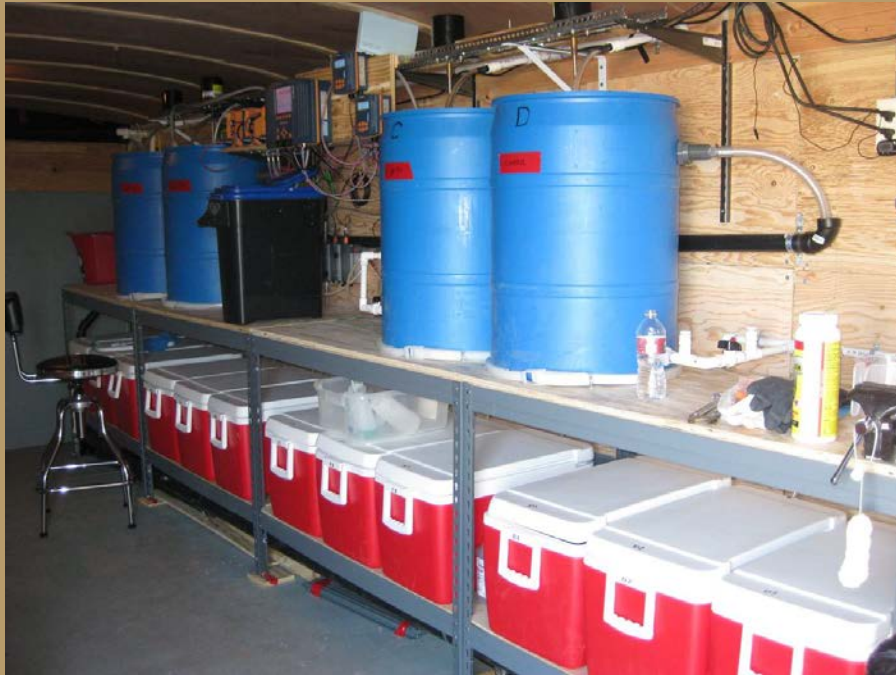
pH up and pH down evaluation

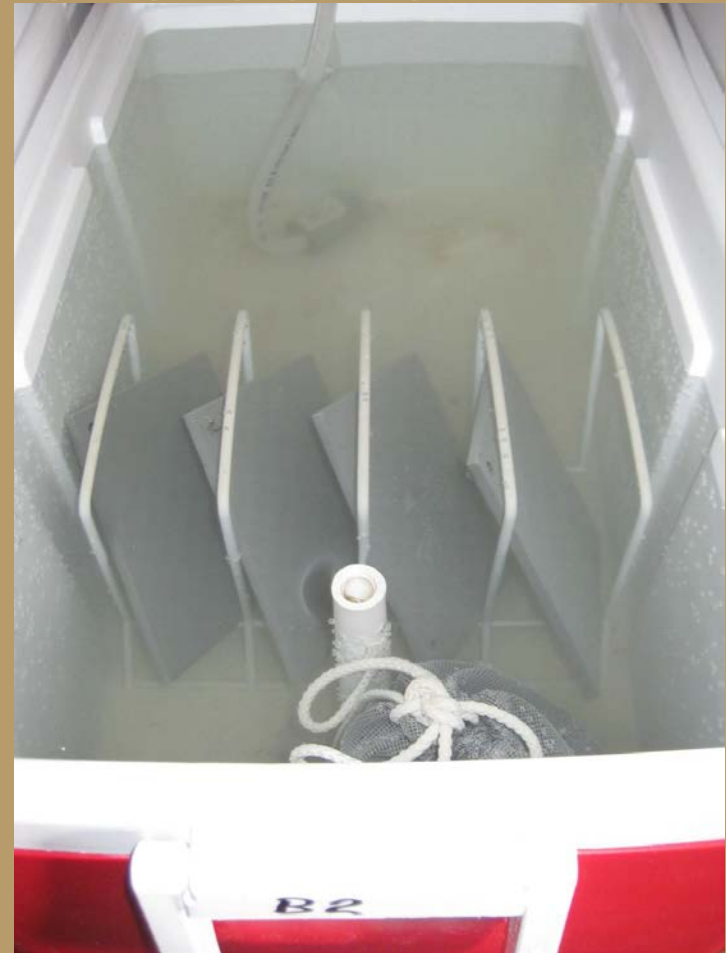
Precipitate observed after 24 hours at pH 9.3

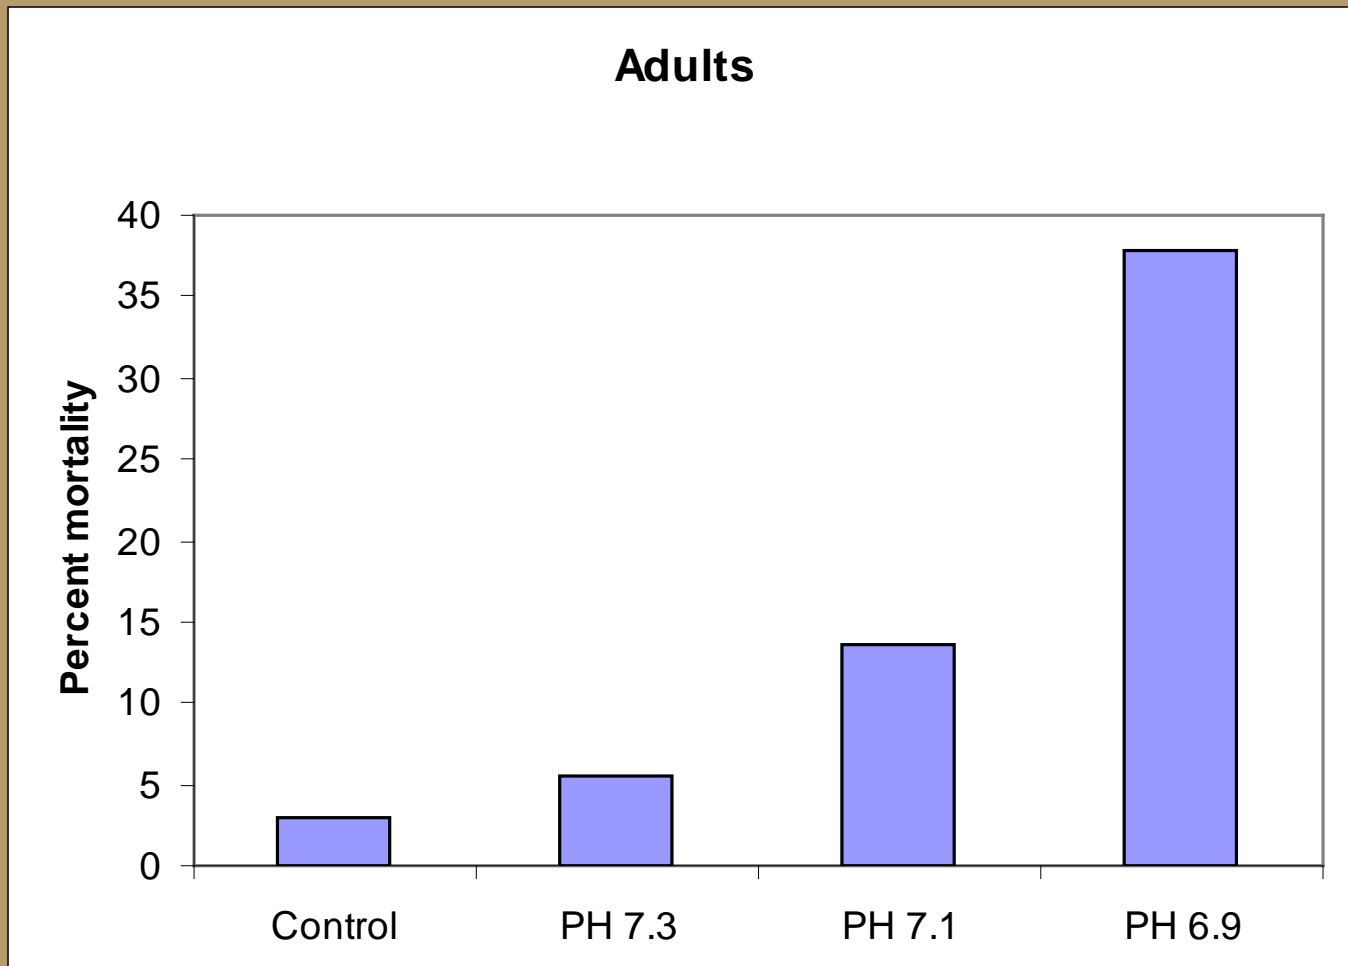
Adult dreissenid mortality in mesh bags after 12 week exposure

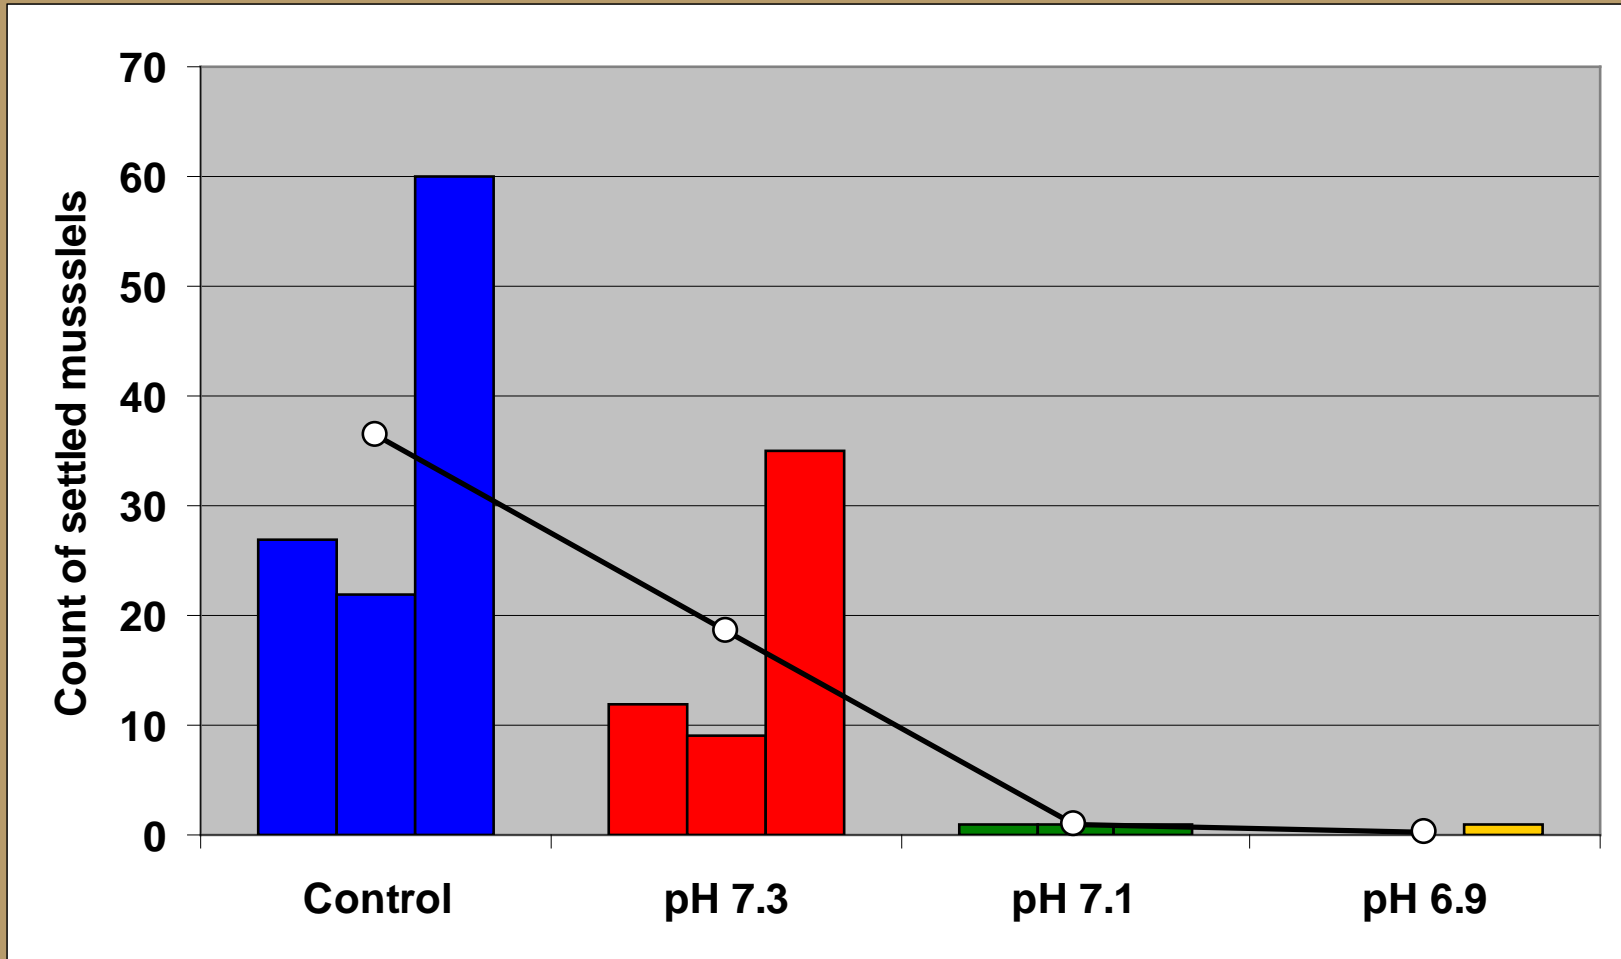
Evaluation of new settlement from August 15th to November 15/09
